**Re: Albany County Septic System Impact Assessment  
Final Reports - Wenck Project – B7218-0001 WYALB101**

# ALBANY COUNTY SEPTIC SYSTEM IMPACT ANALYSIS

The purpose of this report is to present the approach and results of the Septic System Impact Analysis that has been performed in the Casper Aquifer Protection Area (CAPA) for Albany County east of Laramie, Wyoming. Albany County initiated this study due to potential contamination of the Casper Aquifer from septic systems, particularly nitrate. The Casper Aquifer consists of saturated portions of the Casper Formation that crops out east of Laramie. The vadose zone consists of the unsaturated sediments and rock that overlie the aquifer. To assess the water quality conditions beneath one septic system, Wenck Associates (Wenck) installed a vadose zone monitoring network to monitor septic leach field denitrification over Casper Formation outcrop.

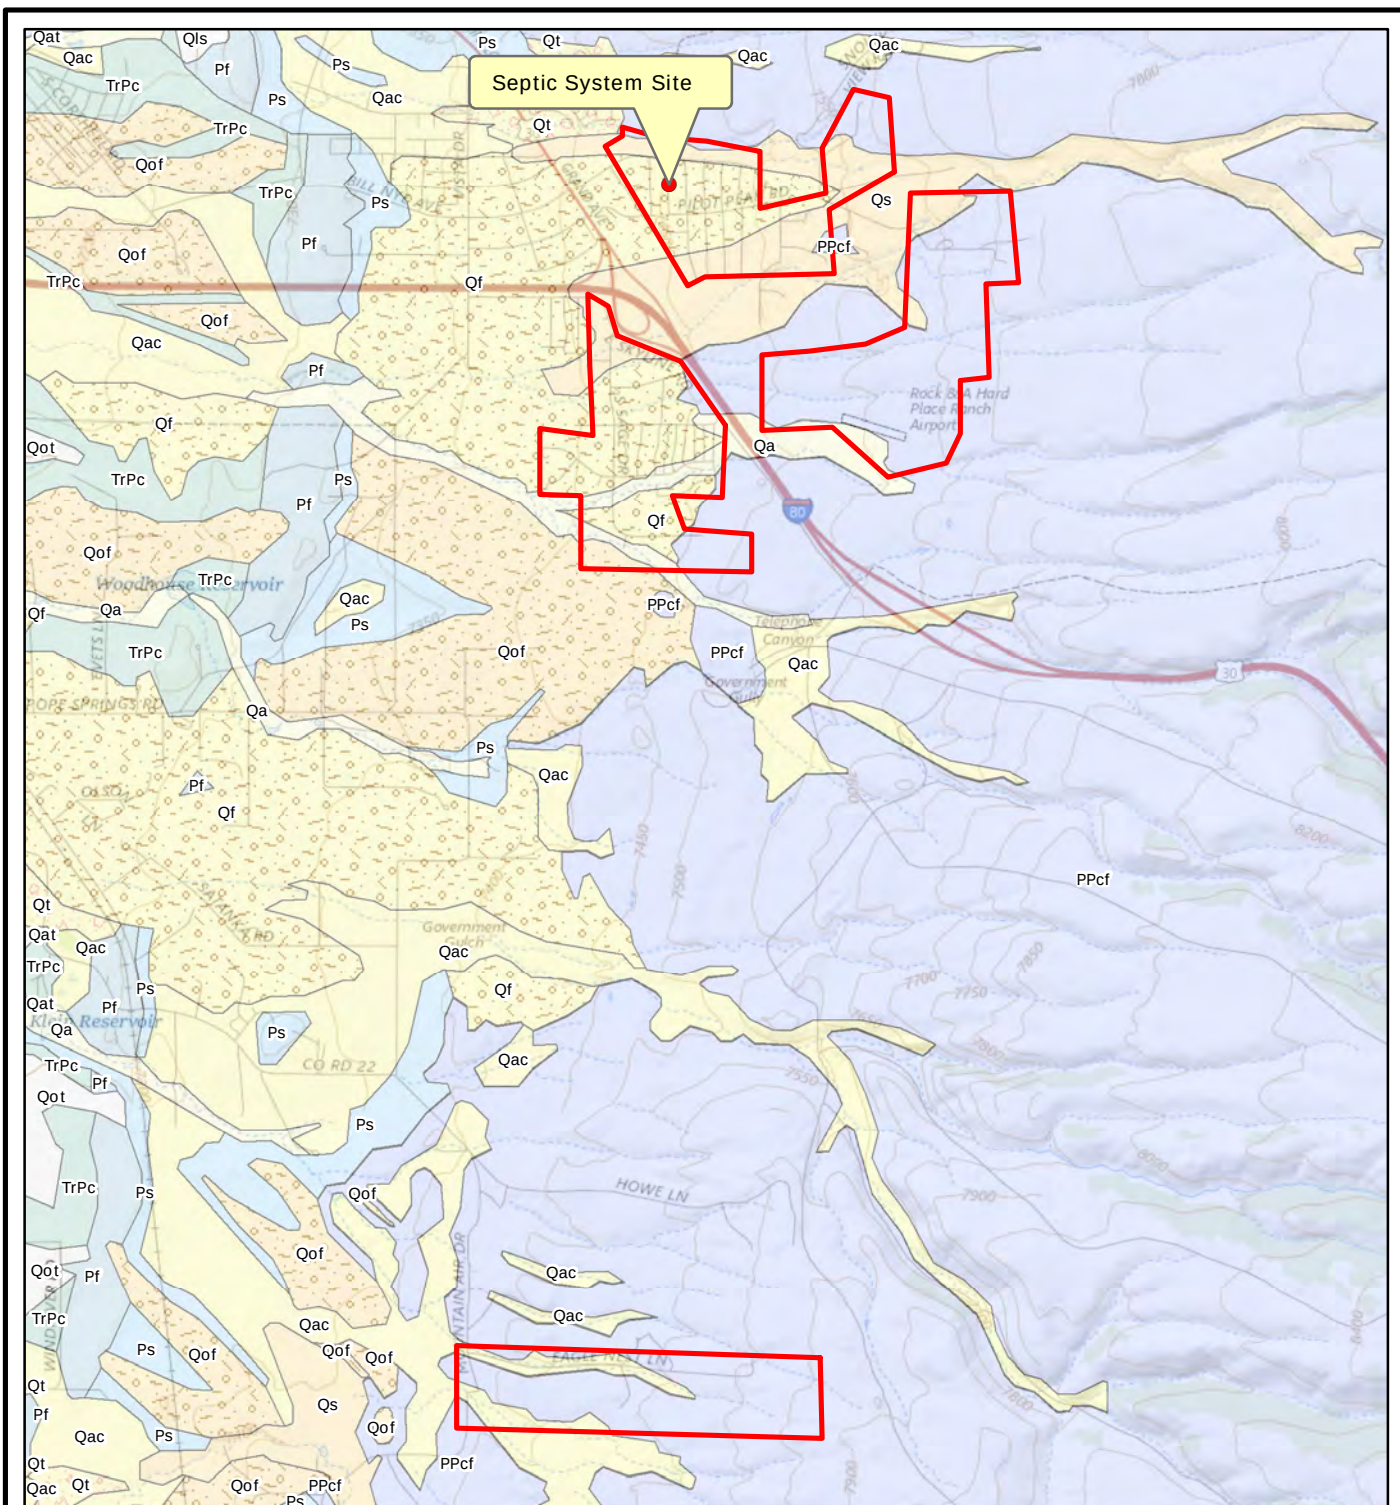
Source: Ver Ploeg, A.J., and Boyd, C.S., 2007, Geologic map of the Laramie 30' x 60' Quadrangle, Albany and Laramie Counties, Southeastern Wyoming: Wyoming State Geological Survey, Map Series MS-77, scale 1:100,000

The Casper Formation is recharged through its outcrop area shown on the east half of **Figure 1** and yields groundwater to local domestic and public supply wells. Its outcrop extends from the Wyoming state line on the south to Wyoming Highway 34 on the north, and dips about 3 to 5 degrees west into the Laramie Basin. The aquifer is principally recharged through snowmelt runoff over outcrop areas in March and April (WWC, 2015), and may receive some component of recharge from the underlying Precambrian Granite along fractures. Recharge due to these runoff events typically occurs within days to weeks indicating rapid movement through the unsaturated zone. Groundwater production from the Casper Aquifer is generally limited to 5 to 50 gallons per minute where intergranular permeability is predominant but ranges up to 2,000 gallons per minute where aquifer permeability has been enhanced by geologic structures, faults, fractures, and bedding surfaces. It is this high capacity production that renders the aquifer suitable for use by the City of Laramie at its Turner, Pope, and Soldier Springs wellfields (WWC, 2006).

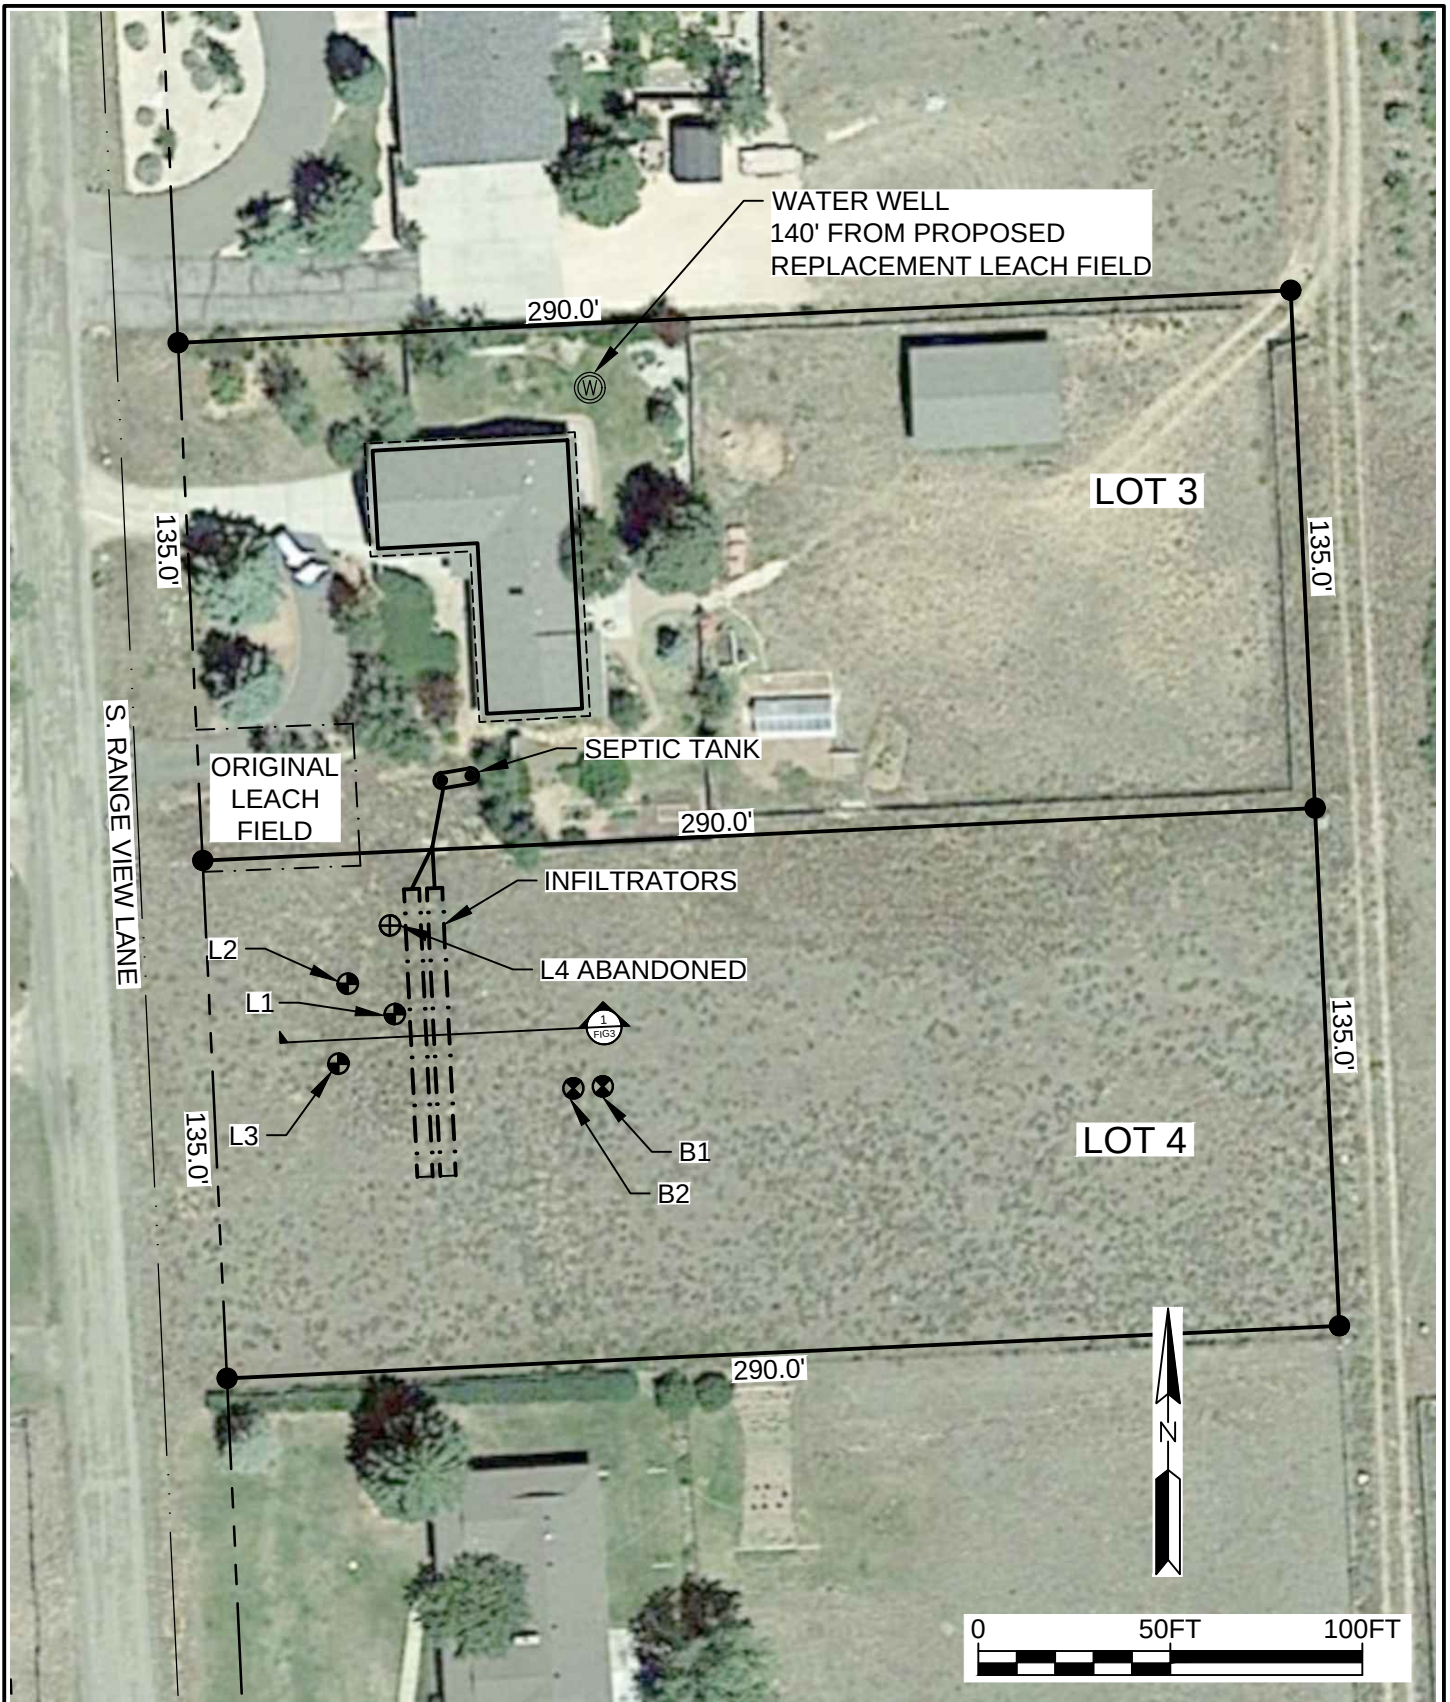
At the locations shown on **Figure 2**, two test holes, B-1 and B-2, were drilled on February 12, 2018, east of the septic system. Groundwater was not encountered in either test hole. Both of these holes were drilled outside the septic system footprint. B-1 was drilled to initially assess the subsurface conditions. B-2 was drilled to determine the thickness and composition of the soil, unconsolidated sand, and Casper Formation material; obtain samples of the unconsolidated sand and Casper Formation; and evaluate shallow groundwater conditions close to the septic system. Because groundwater was not encountered in either test hole, monitoring wells were not installed. Given the reported depth to water in the residential well, the Casper Aquifer (saturated Casper Formation) underlies the site, but the depth at which groundwater would have been encountered is uncertain. Wenck discussed the possibility of completing a monitoring well west and downgradient of the septic system to monitor nitrate concentrations in near surface groundwater, but Albany County and the City of Laramie opted not to pursue its completion. Lithologic logs of these two test holes are included in **Appendix C**.

As shown on **Figures 2 and 3**, four lysimeter holes were drilled west of the western infiltrator at the site for the vadose zone monitoring network. Between February 13 and 14, 2018, Authentic completed the installation of the lysimeters in L-1 through L-4. L-4 was drilled first but was plugged and abandoned after damaging the western infiltrator. All In One Septic Systems and Plumbing Service (All In One) excavated and repaired the damaged infiltrator after the other lysimeters had been installed. The lysimeter holes were drilled with new 8.25-inch diameter hollow stem augers that had not been used prior to this project. Each auger was decontaminated between holes. Bulk soil samples from each lysimeter hole (L-1 through L-3 only) were also collected for laboratory testing and analysis. At L-1 and L-2 beneath approximately 1 foot of silty sand or sandy silt soil, unconsolidated sand of the alluvial fan deposits was encountered to the bottom of each lysimeter hole as shown on **Figure 3**. L-1 was completed with lysimeters set at vertical depths of 5 and 12 feet below ground surface in the unconsolidated sand. L-2 was completed with lysimeters set at depths of 19 and 25 feet, respectively, in the unconsolidated sand. However, the lysimeter at 25 feet was set at or near the interface between the unconsolidated sand and Casper Formation. At L-3, similar sediments were observed to a depth of 33 feet, at which point a

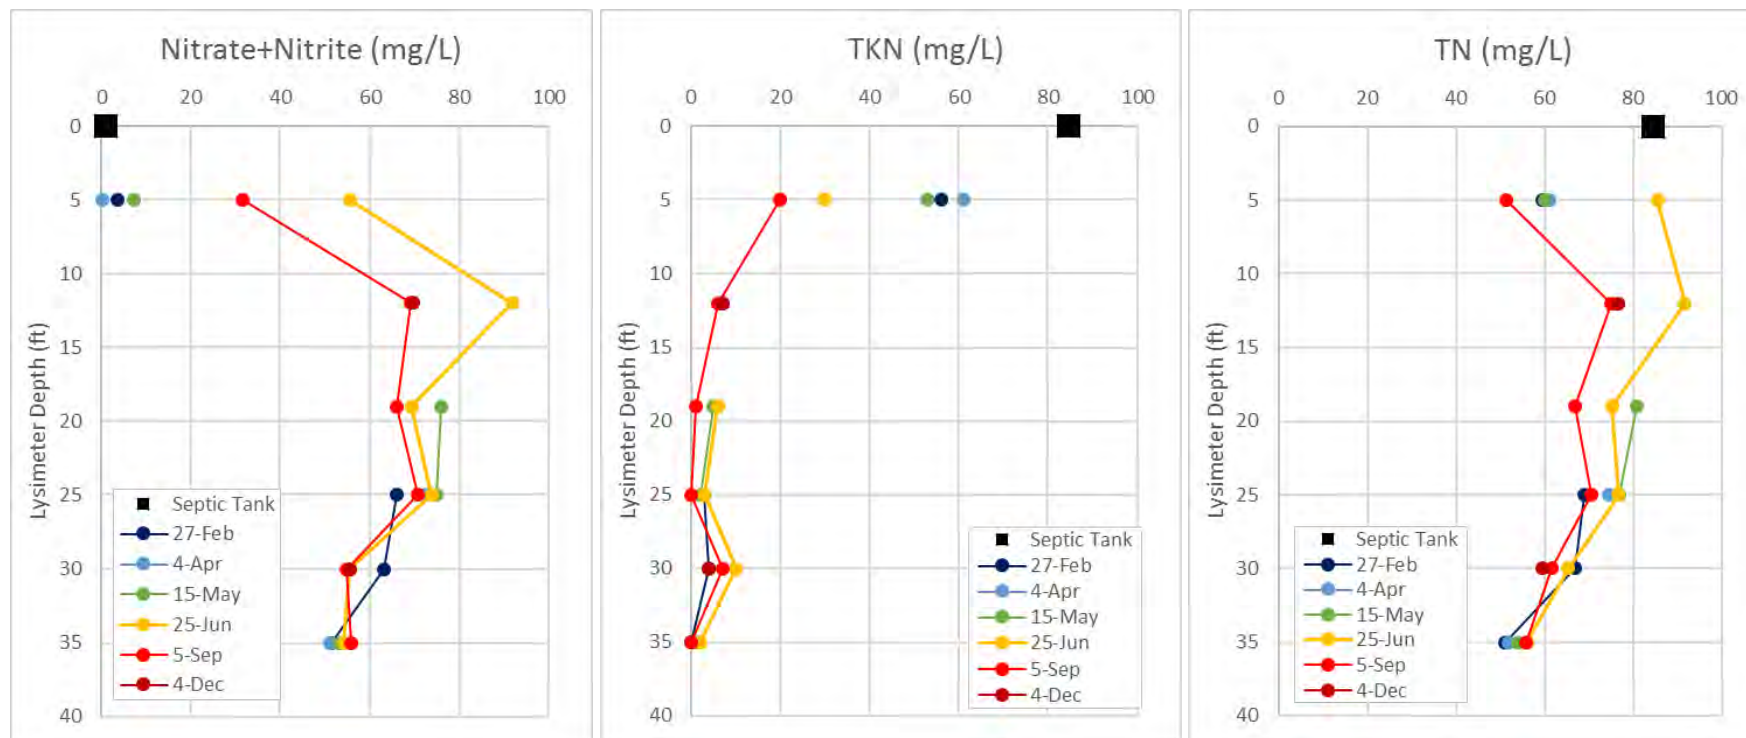
**Figure 4: Lysimeter Moisture Quality Depth Profiles**

As discussed in the previous section, nearly all of the nitrogen in the septic tank is in ammonia form prior to being discharged to the infiltrators. The lysimeter profiles shown on **Figure 4** indicate that TKN concentrations decrease significantly in the top 12-feet of the vadose zone as the average TKN concentration (all sample events) for the lysimeter located 12-feet below grade is approximately 92% lower (6.5 mg/L) than the average TKN concentration in the septic tank (84.5 mg/L). TKN levels continue to decrease between the 12-foot and 35-foot lysimeters, however, not as dramatically as the TKN decrease in the upper 12 feet of the vadose zone. Average TKN concentrations decrease from 6.5 mg/L at the 12-foot lysimeter to 0.8 mg/L at the 35-foot lysimeter, suggesting nitrification and/or ammonia adsorption continues to occur throughout this part of the vadose zone.

The lysimeter profiles also indicate that the TKN changes in the upper 12-feet of the vadose zone coincide with significant increases in nitrate+nitrite concentrations. As discussed in Section 5.1, nitrate+nitrite concentrations in the septic tank were below laboratory reporting limits. Nitrate+nitrite concentrations for the samples collected within the unconsolidated sand at the 5-foot and 12-foot lysimeters averaged 19.6 mg/L and 76.9 mg/L, respectively. These increases indicate a majority of the TKN (i.e. ammonia) discharged from the septic tank is adsorbed to the soil and/or converted to nitrate in the upper 12-feet of the vadose zone. The data shows these processes occur more rapidly in the upper 5-feet of the vadose zone during the warmer summer months, because the June and September nitrate+nitrite samples (55.6 mg/L and 31.5 mg/L) were significantly higher than the nitrate+nitrite samples collected in the 5-foot lysimeter in February, April, and May (3.6 mg/L, 0.2 mg/L and 7.1 mg/L, respectively).

The lysimeter profiles show that nitrate+nitrite levels begin to decrease in the deeper part of the vadose zone below 12 feet. Average nitrate+nitrite concentrations go from 76.9 mg/L at the 12-foot lysimeter to 53.1 mg/L at the 35-foot lysimeter (~31% reduction), suggesting that some denitrification and/or dilution with non-septic water occurs as water moves through this portion of the vadose zone. Unlike the upper vadose zone, the TKN and nitrate+nitrite changes in the deeper vadose zone appear to be relatively consistent between the six sample events which suggests that denitrification rates in the lower vadose zone are relatively consistent throughout the year. Nitrate concentrations in the upper 10 feet of the Casper Formation (i.e. lysimeter depths 30 and 35 feet) range from 51 to 63 mg/L.

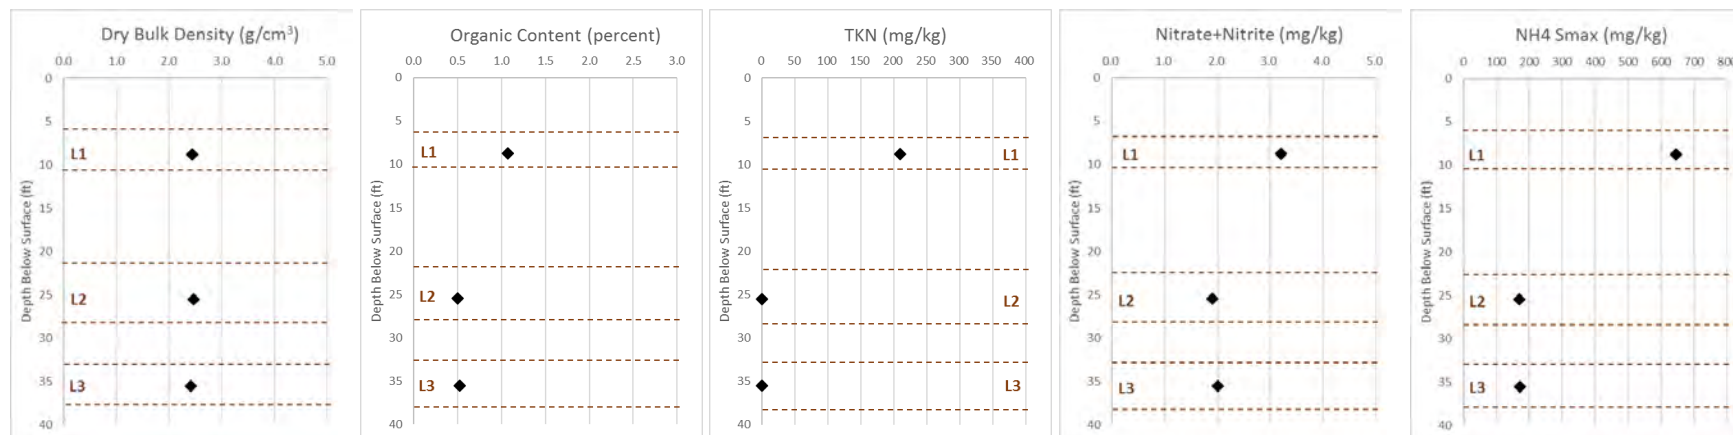
**Figure 5: Soil Sampling Laboratory Results for the Lysimeter Holes**

Physical and chemical analysis results for the vadose zone soil samples collected from the lysimeter holes beneath the septic infiltrators and the non-septic impacted area east of the leach field (Test Hole B-2) are presented in **Tables 5.3** and **5.4**, respectively. **Figures 5** and **6** display vertical profiles of the soil dry bulk density, organic content, TKN, nitrate+nitrite, and ammonia sorption maximum for the septic and non-septic impacted areas. **Appendix E** contains a more detailed laboratory report of the analytical methods along with a brief discussion of the results.

Soil dry bulk density was measured in three layers at the lysimeter holes (L1, L2 and L3) and ranged from 2.41 g/cm<sup>3</sup> to 2.46 g/cm<sup>3</sup> suggesting soil physical properties are very similar throughout the entire vadose zone beneath the infiltrators. Soil bulk density was also measured in three layers at B-2 (B2-1, B2-2 and B2-3) east of the leach field. Results ranged from 2.32 g/cm<sup>3</sup> to 2.60 g/cm<sup>3</sup> indicating soil physical characteristics were also consistent through the vadose zone in this area and spatially between the two areas.

Soil results did show that the vadose zone beneath the infiltrators is able to adsorb some ammonia. Ammonia sorption maximums are relatively low as less than 15% of the ammonia in the laboratory standard was adsorbed to the soil. Ammonia sorption maximum for the upper vadose zone (station L1) was approximately four times higher (645 mg/kg) than the deeper vadose zone (stations L2 and L3) beneath the infiltrators.

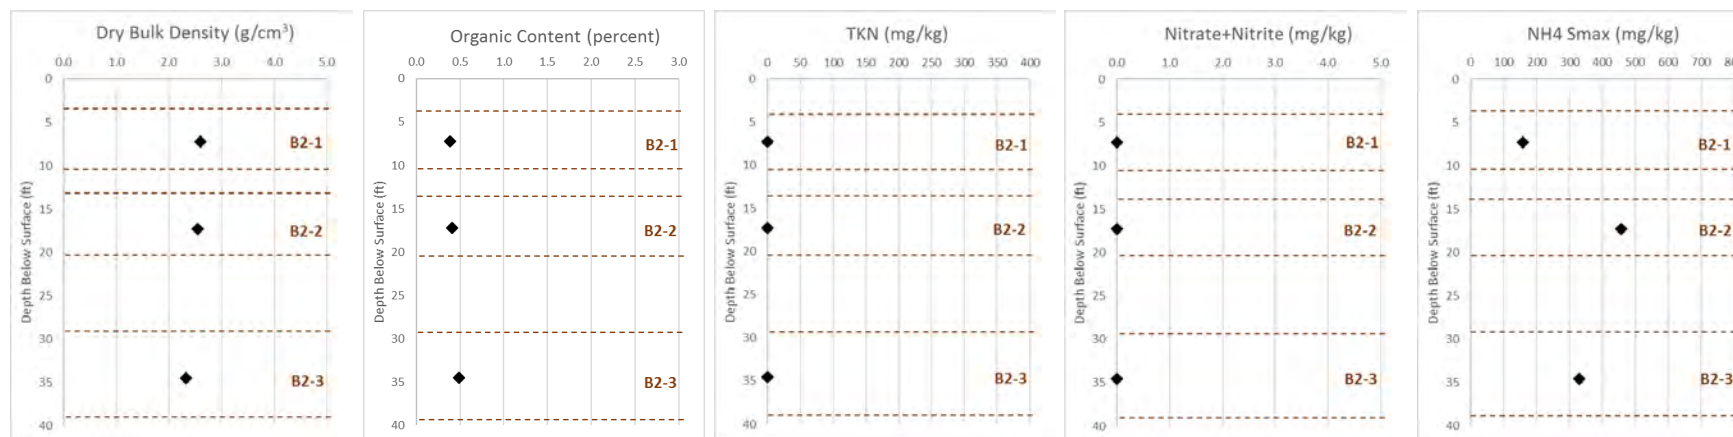
**Figure 6: Soil Sampling Results for Test Hole B-2 East of the Infiltrators (non-septic impacted area)**

Soil sample results at Test Hole B-2, which reflects the non-septic impacted area, did not show any variability in organic content, TKN and nitrate+nitrite concentrations throughout the vadose zone. Soil organic content was consistently low at all three stations (B2-1, B2-2 and B2-3) throughout the vadose zone. Similarly, TKN and nitrate+nitrite concentrations were below reporting limits at all three stations.

Soils at Test Hole B-2 also showed some capacity to adsorb ammonia. Ammonia sorption maximums were generally low and less than 10% of the ammonia standard was adsorbed. Unlike the septic impacted area beneath the infiltrators, ammonia sorption maximums were higher in the deeper vadose zone.

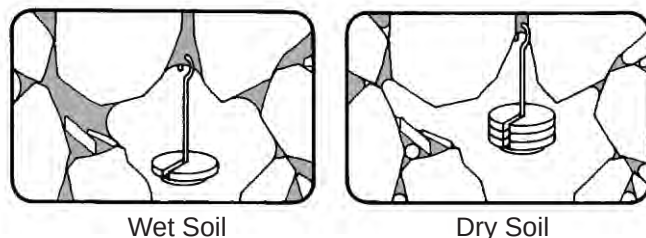
The following illustration (see Figure 1) shows the increasing force required to remove water from the small-sized capillary pores compared to the large pores as the soil dries out. When the remaining water is held only in extremely small pore spaces, it requires more energy to remove the water from these pores. Even though there may be a considerable volume of water in the soil, the tension that holds the water determines how readily it can be removed.

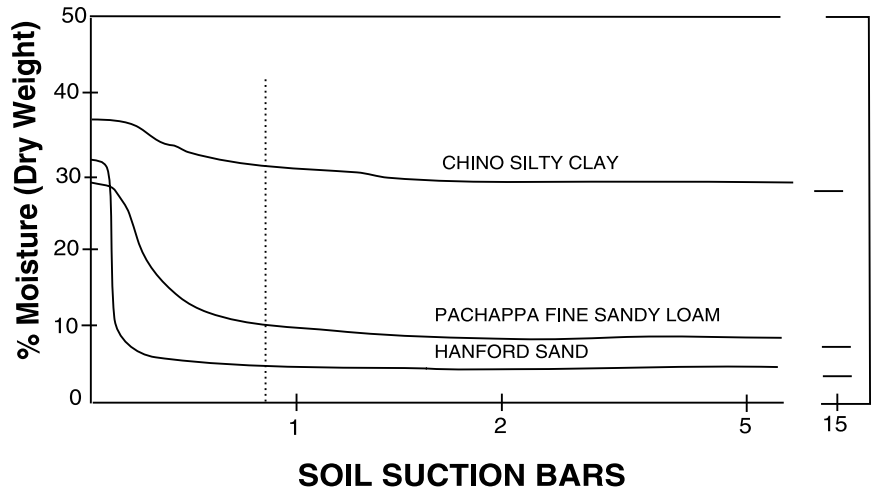
Figure 2.

The following graph shows the relationship between the percent of moisture in a soil and the soil suction required to remove the moisture from three types of soil: clay, loam, and sand.

from a sandy soil with 10% moisture, than it is to remove water from a clay soil with 30% moisture. This is because the water in the clay soil is held in very small capillary spaces within the soil particles under a higher soil suction, whereas the sandy soil holds water in large capillary spaces under a lower soil suction.

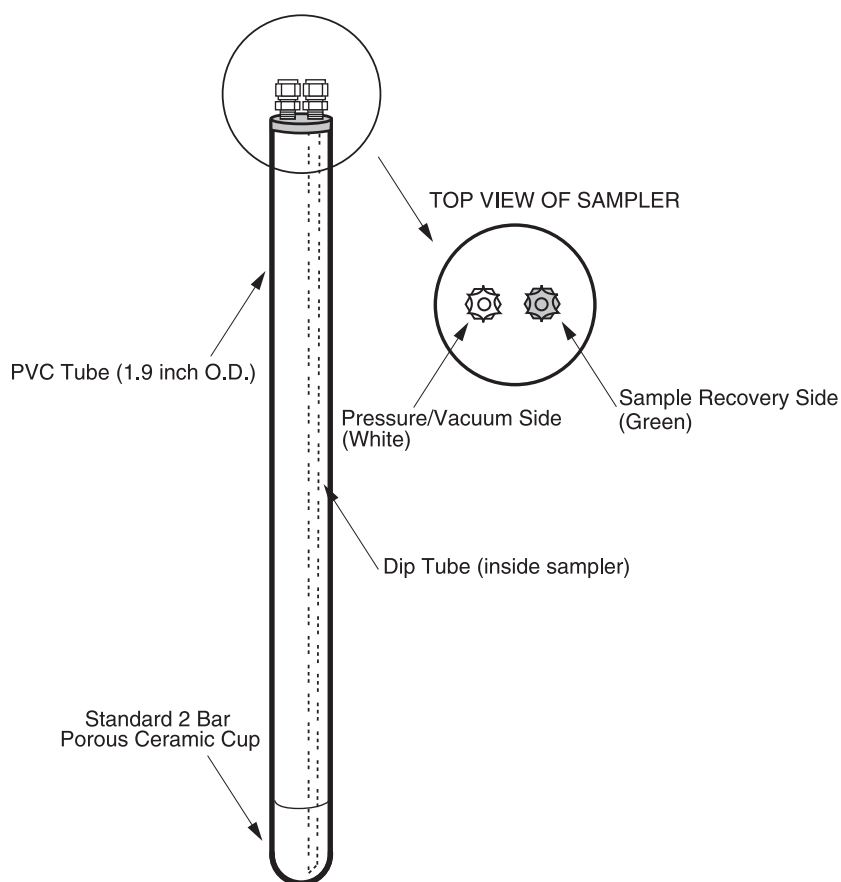
Two 1/4-inch O.D. polyethylene access tubes are used for pressurizing and recovering samples which are terminated in neoprene tubing. Clamping rings are used to clamp the neoprene to keep the Sampler

Figure 3. Pressure-Vacuum Soil Water Sampler

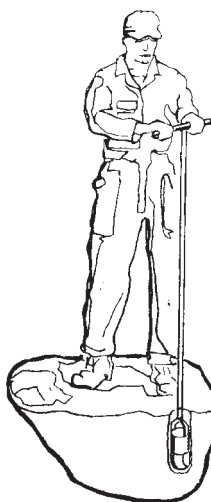
Figure 4a.

In rock-free, uniform soils at shallow depths, use a 2-inch screw or bucket auger for coring the hole (Figure 4a). If the soil is rocky, a 4-inch auger should be used. The soil is then sifted (Figure 4b) through a 2mm mesh screen or 2mm sieve to free it of pebbles and rocks.

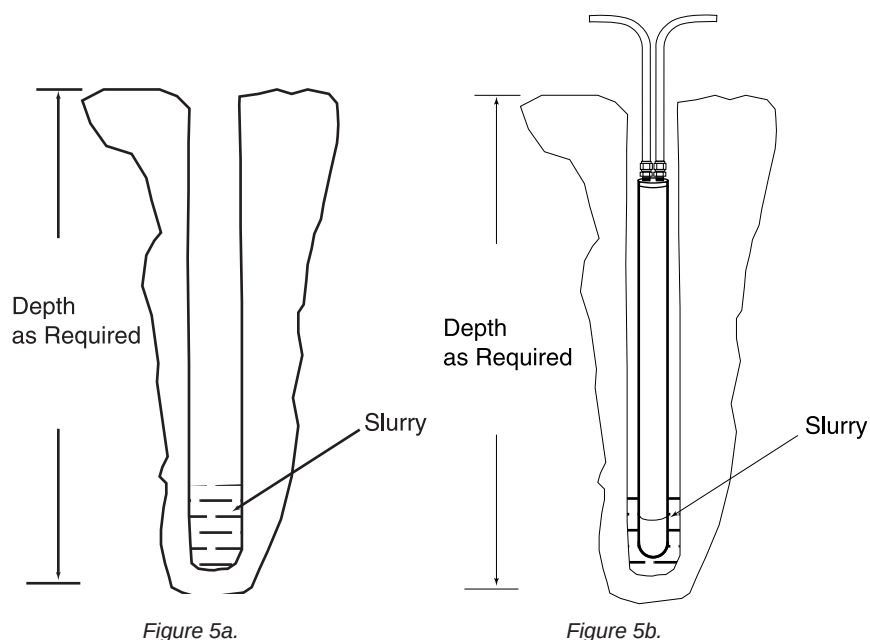
After the hole has been cored, mix sifted soil with water to make a slurry which has a consistency of cement mortar. This slurry is then poured down to the bottom of the cored hole to insure a good soil contact with the porous ceramic cup (see Figure 5a).

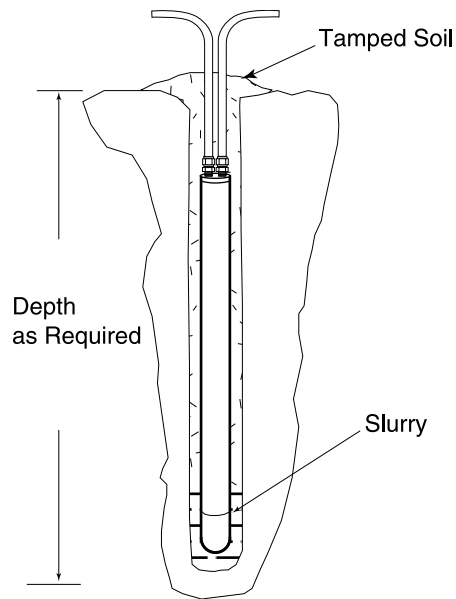
Figure 6.

Backfill the remaining area around the Sampler with sifted soil which is free of pebbles and rocks, a 2mm sieve is popular for this. Tamp the soil firmly to prevent surface water from running down the cored hole, or make a bentonite seal. (see Fig. 6)

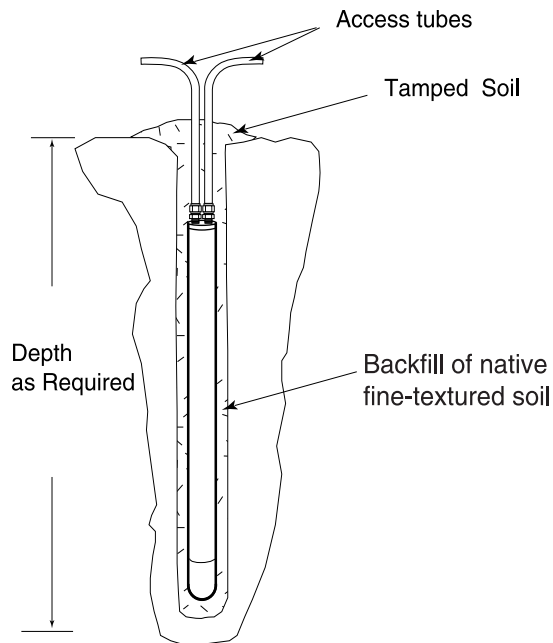
Figure 7.

If the soil into which the Sampler is being installed is fine-textured and free of rocks, a slurry may not be necessary. Core the hole to the desired depth, insert the Soil Water Sampler and backfill the hole with native soil, tamping continuously to insure good soil contact with the porous ceramic cup and complete sealing of the cored hole (see Figure 7).

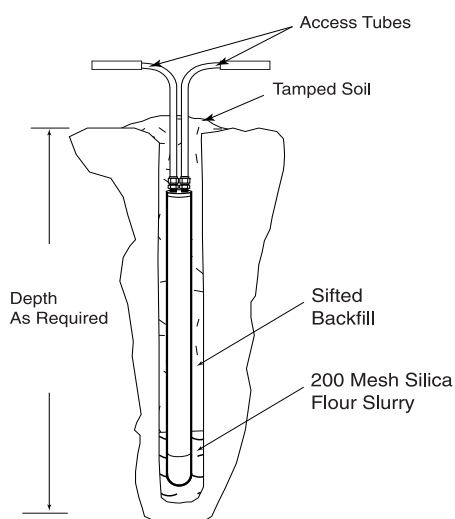
Figure 8.

Core the hole to the desired depth, and pour in about 1/4 of the silica slurry. Insert the Soil Water Sampler and pour in the remainder of the slurry so that the slurry completely covers the ceramic cup. Backfill the hole with sifted soil (free of pebbles and rocks), tamping continuously with a metal rod to prevent surface water from channeling down between the soil and the body tube of the Sampler (see Figure 8).

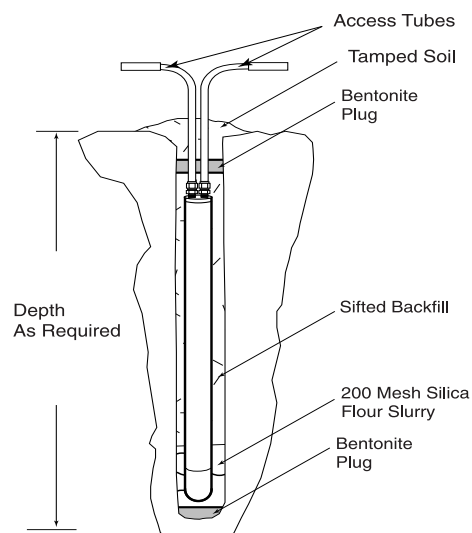
Figure 9.

To ensure that disturbed soil resulting from the installation of the Sampler does not affect the movement of water to the Sampler, Bentonite clay plugs can be installed. Core the hole a few inches deeper than the desired depth, and pour in several inches of wet Bentonite clay (see Fig. 9). This will isolate the Sampler from the soil below. Pour in 1/4 of the slurry, either of soil or of Silica, and insert the Soil Water Sampler. Pour the remainder of the slurry around the cup of the Soil Water Sampler. Backfill with native soil to a level just above the Soil Water Sampler and again add sufficient Bentonite as a plug to further isolate the Soil Water Sampler and guard against possible channeling of water down the hole. Backfill the remainder of the hole slowly, tamping continuously with a metal rod using native soil, free of pebbles and rocks.

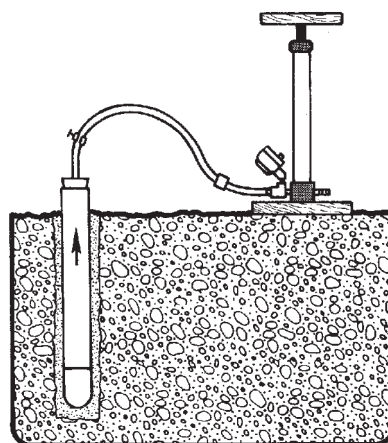
Figure 10.

To collect a sample, the discharge access tube is closed using a clamping ring, and the vacuum port of the hand pump is connected to the Pressure-Vacuum access tube. The pump is then used to create a vacuum of about 60 cb inside the Sampler, which is indicated on the gauge connected to the pump (see Fig. 10).

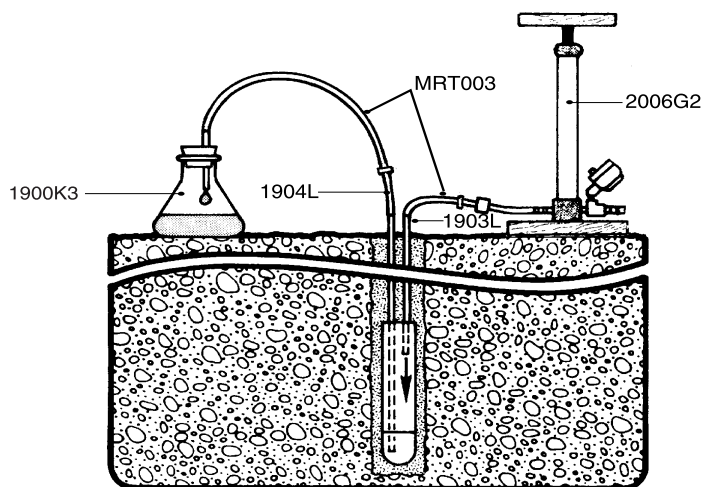
To recover a soil water sample, remove the Pressure-Vacuum tube from the vacuum port of the pump, and attach the tube to the pressure port. Place the discharge access tube in a small collection bottle and remove both clamping rings. Apply a few strokes on the hand pump to develop enough pressure within the Sampler to force the collected water out of the Sampler and into the collection bottle (see Fig. 11).

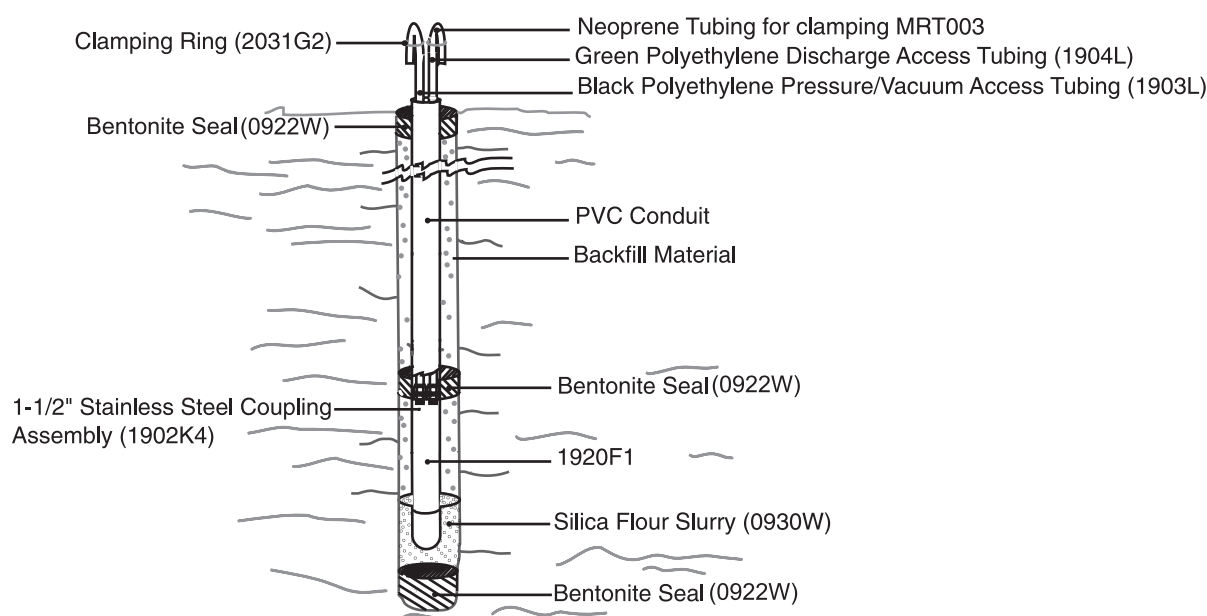
Figure 12. Complete sampler installation with accessories

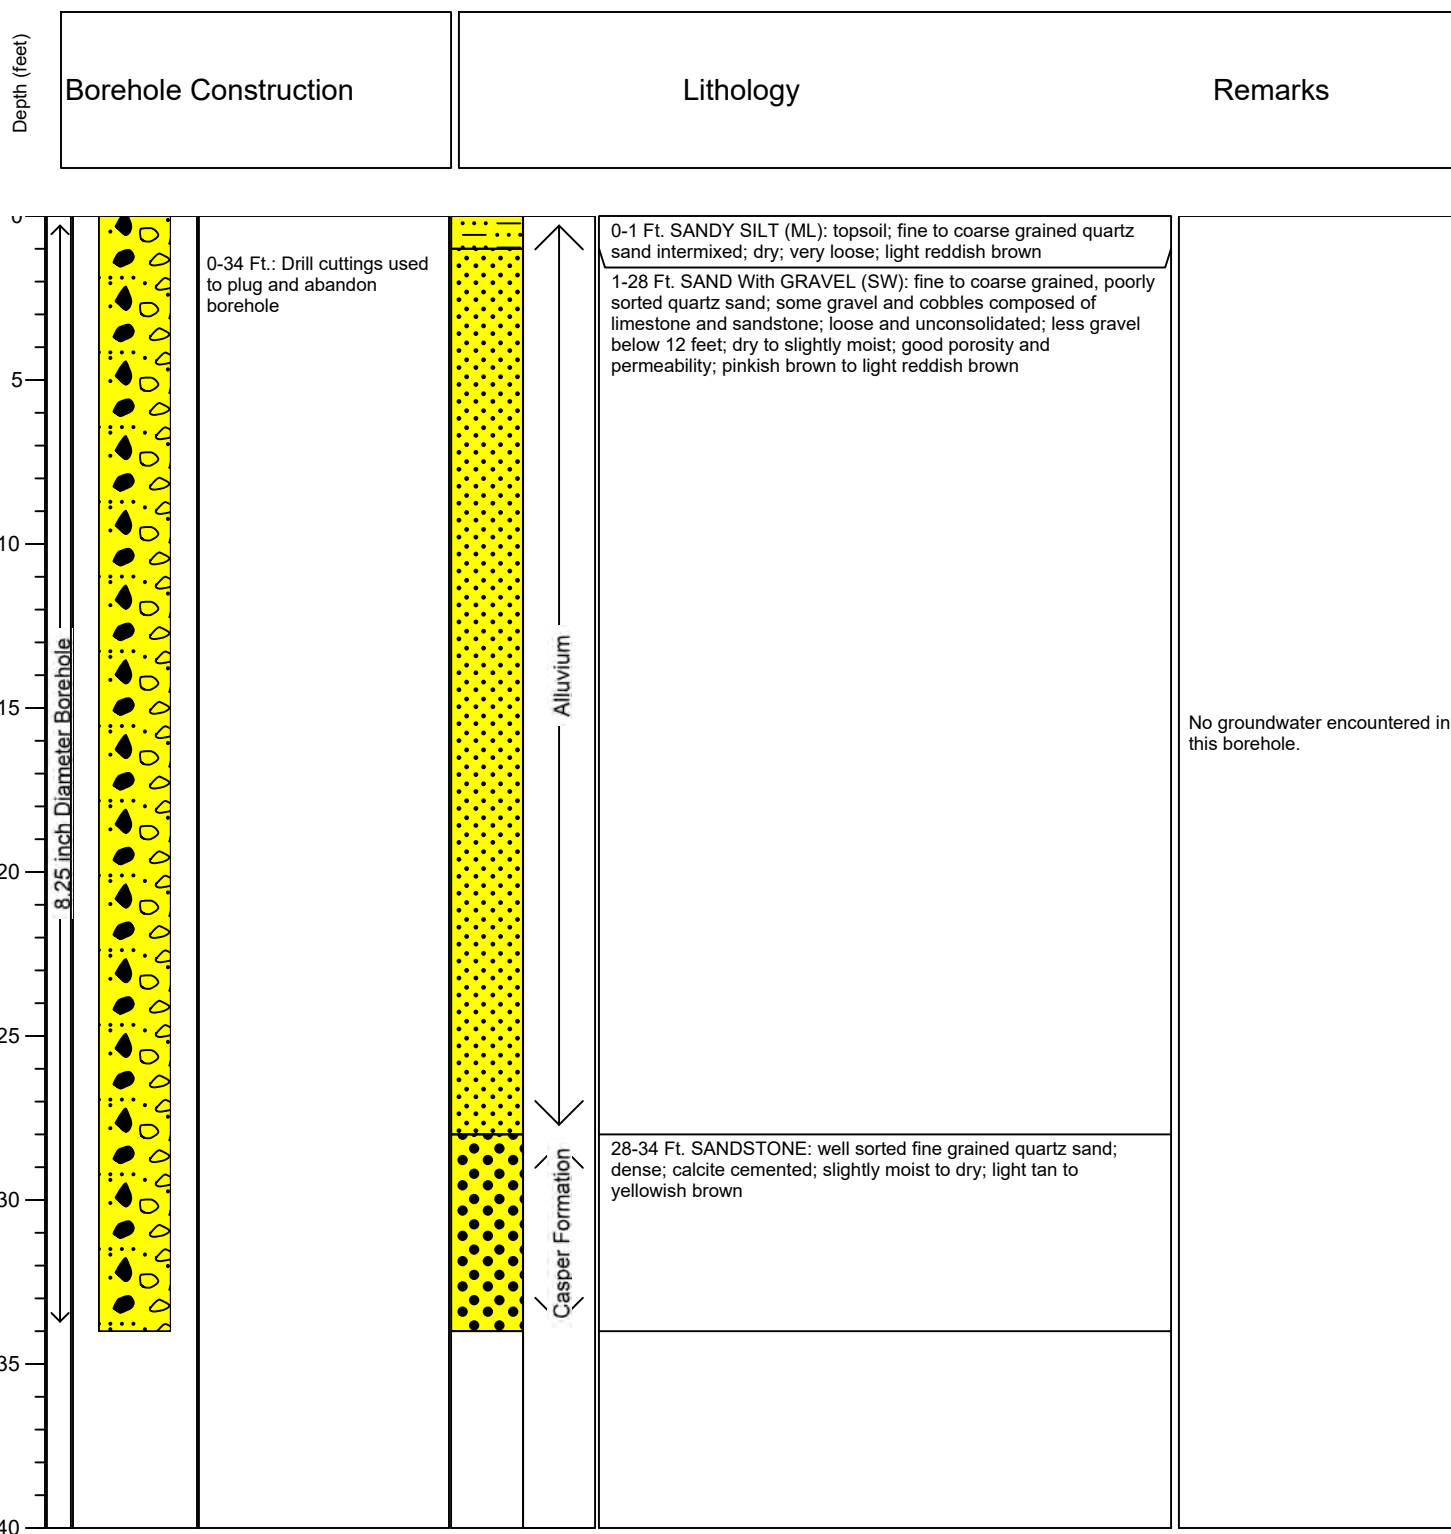
Notes: This figure presents the completion details for the BH-1 test hole. The borehole was drilled east of the septic system at 2225 Range View Lane in Laramie, Wyoming. This hole was drilled to initially investigate soil thickness, depth to bedrock, and saturation conditions adjacent to the septic system. Authentic Drilling drilled the test hole utilizing hollow stem auger methods. Upon completion of drilling, the borehole was backfilled with drill cuttings and abandoned.

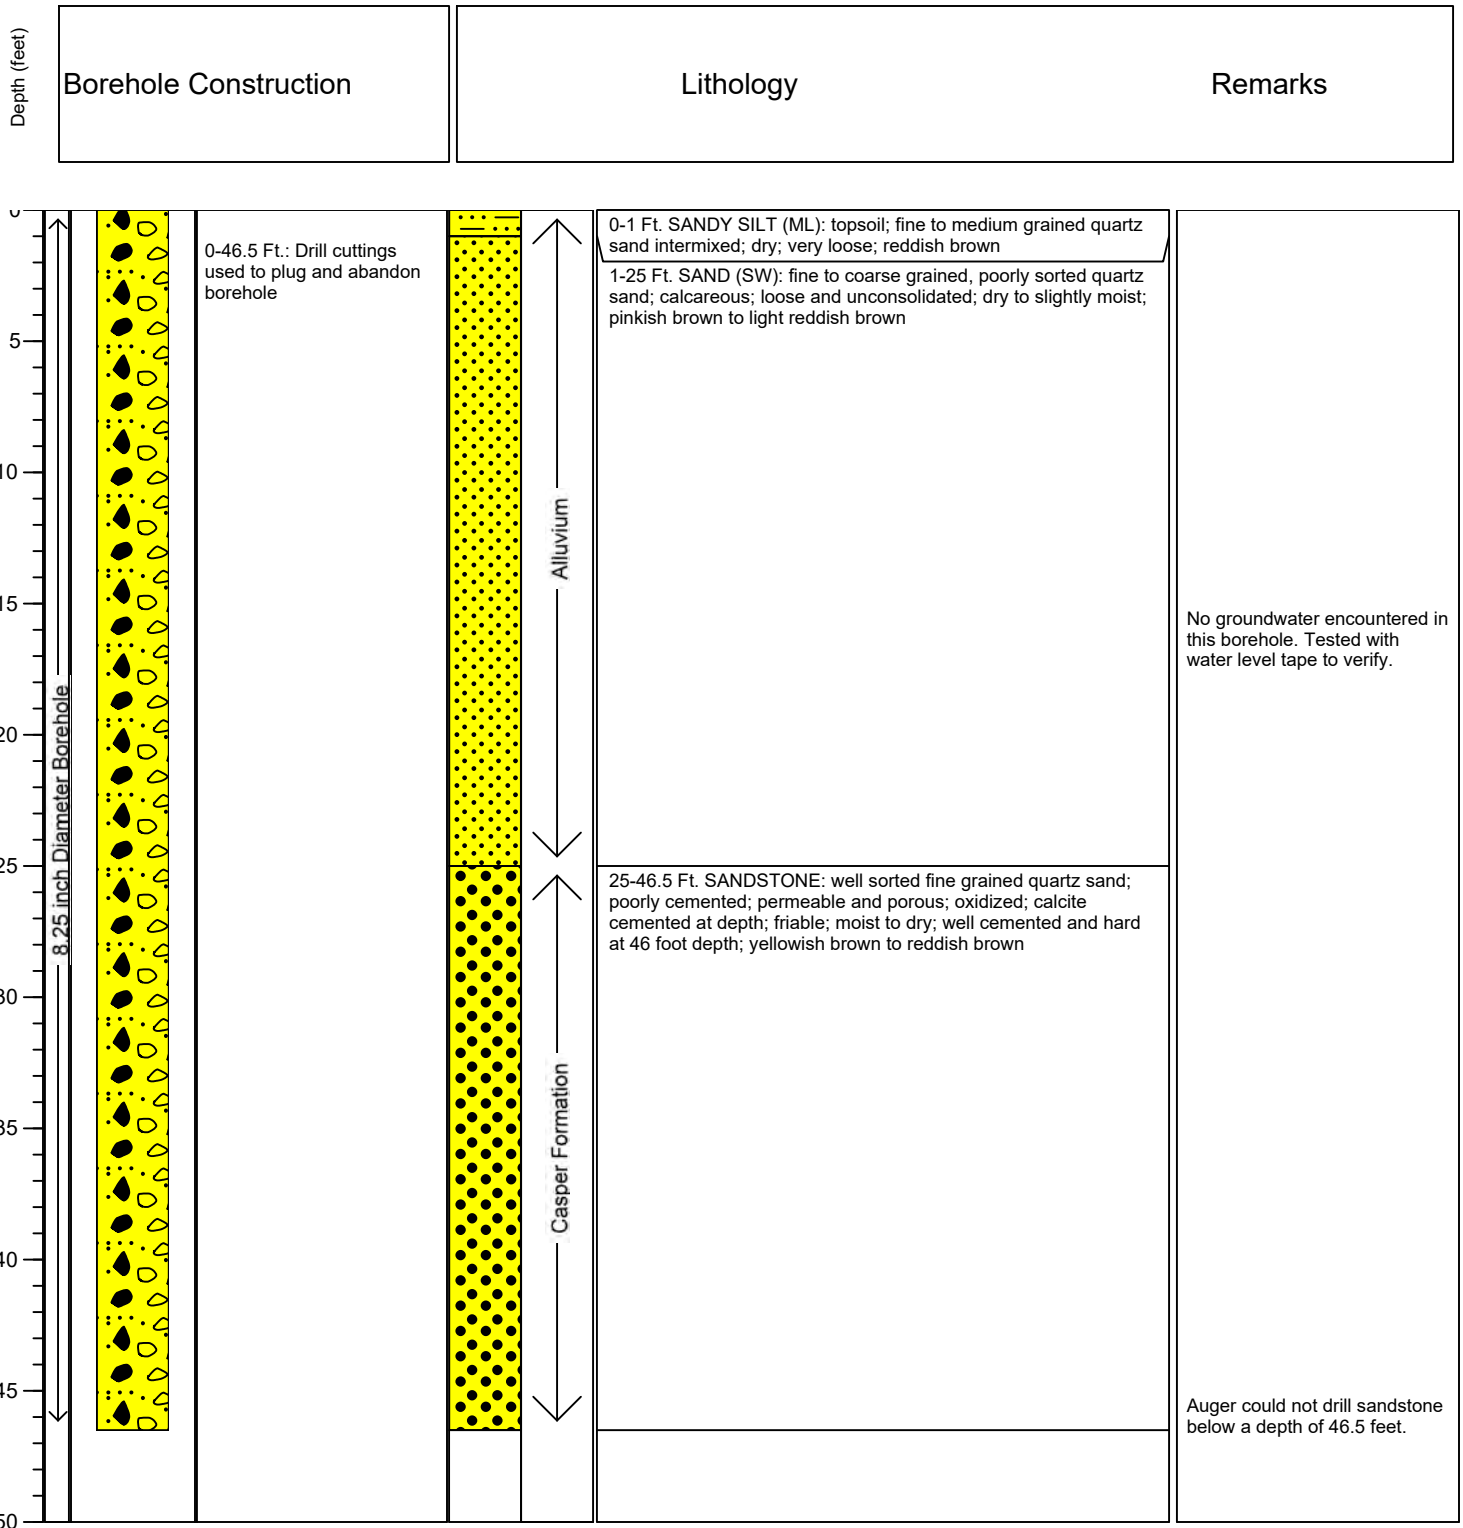
Notes: This figure presents the completion details for the BH-2 test hole. The borehole was drilled east of the septic system at 2225 Range View Lane in Laramie, Wyoming. Located closer to the septic system than BH-1, this hole was drilled to further investigate soil thickness, depth to bedrock, and saturation conditions adjacent to the septic system. Authentic Drilling drilled the test hole utilizing hollow stem auger methods. Upon completion of drilling, the borehole was backfilled with drill cuttings and abandoned.

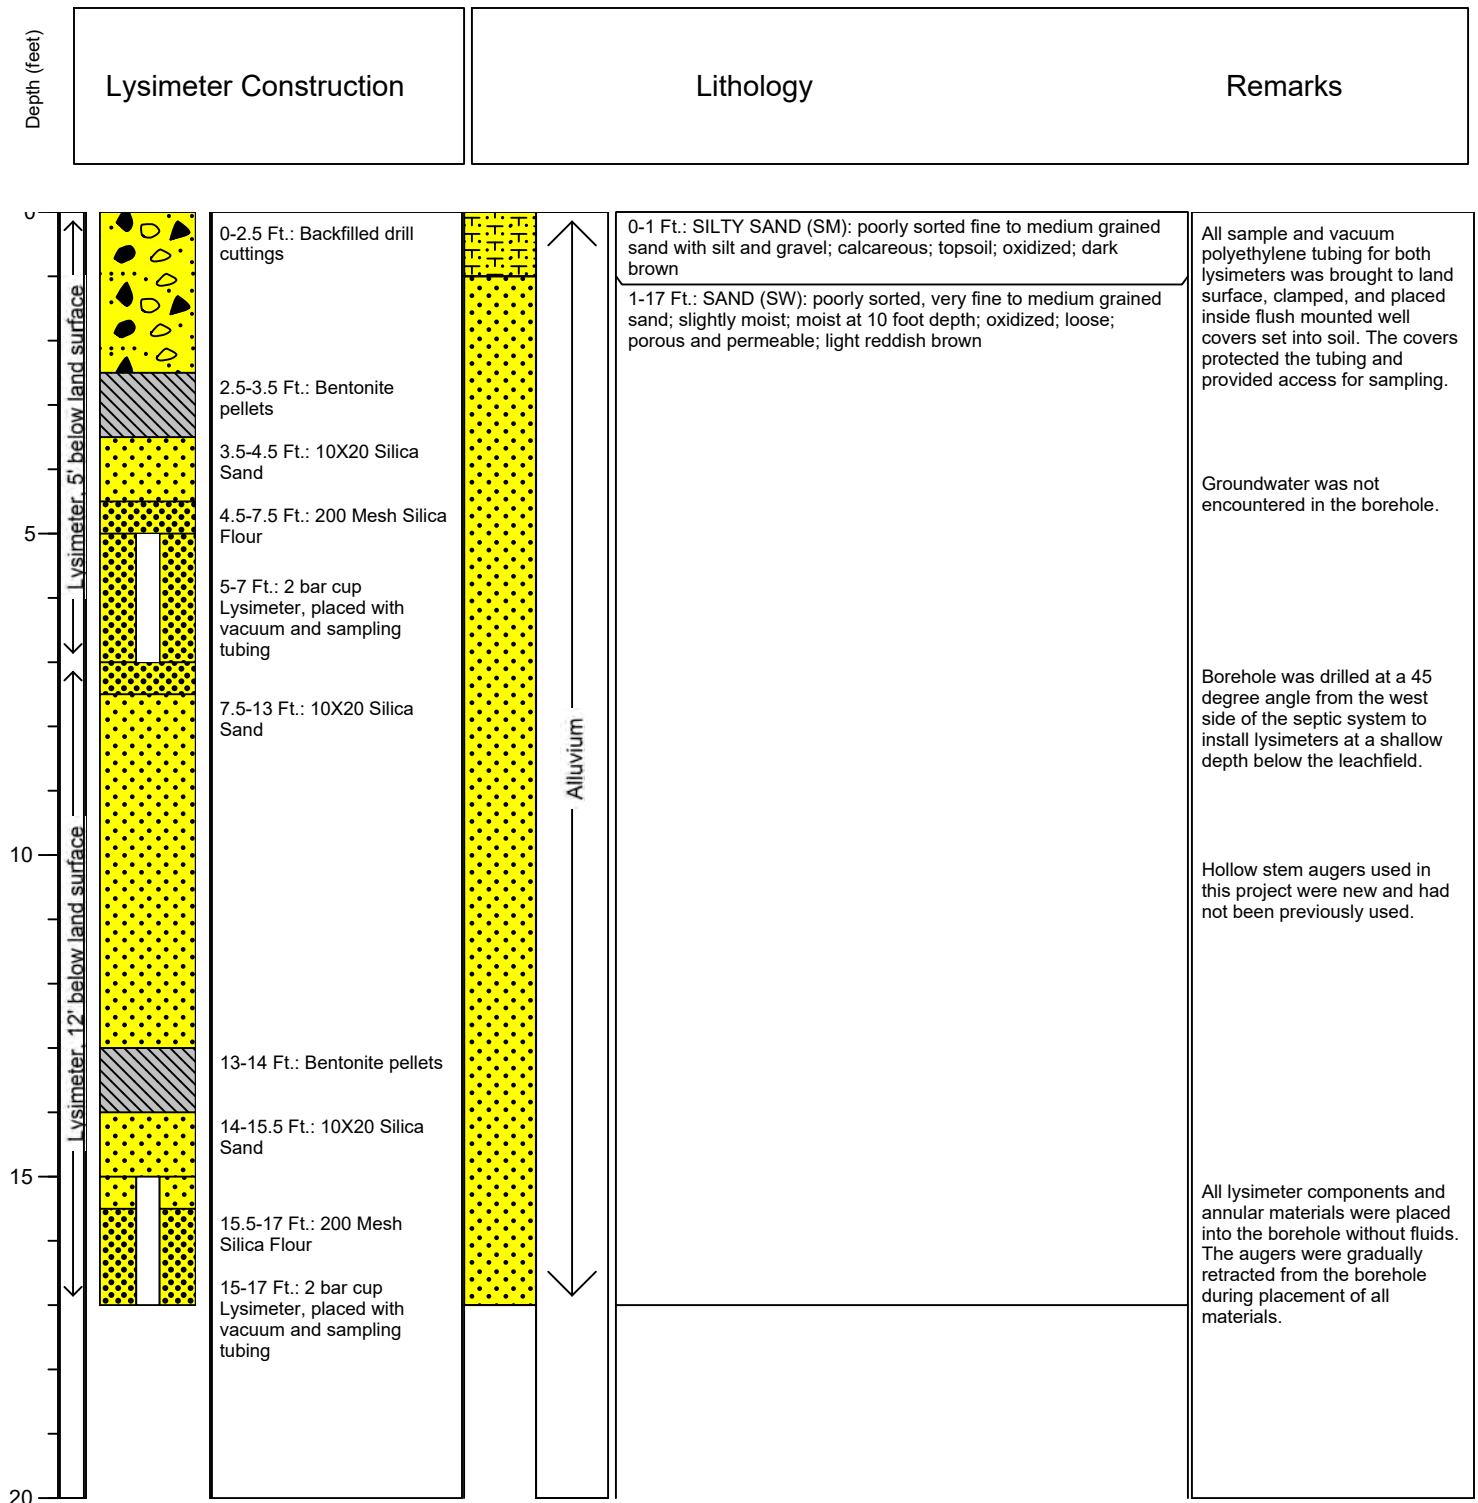
Well Name: L-1  
 Drilling Method: Hollow Stem Auger  
 Logged by: M. Stacy  
 Total depth: 17 Ft.  
 Elevation: 7,457 Ft.

Notes: This figure presents the as-built details for the L-1 lysimeter completed west of the septic system at 2225 Range View Lane in Laramie, Wyoming. This borehole was drilled at a 45 degree angle from vertical to install two, two foot long lysimeters in this one borehole at two different depths below the septic system.
