**Re: Albany County Septic System Impact Assessment  
Final Reports - Wenck Project – B7218-0001 WYALB101**

# ALBANY COUNTY SEPTIC SYSTEM IMPACT ANALYSIS

The purpose of this report is to present the approach and results of the Septic System Impact Analysis that has been performed in the Casper Aquifer Protection Area (CAPA) for Albany County east of Laramie, Wyoming. Albany County initiated this study due to potential contamination of the Casper Aquifer from septic systems, particularly nitrate. The Casper Aquifer consists of saturated portions of the Casper Formation that crops out east of Laramie. The vadose zone consists of the unsaturated sediments and rock that overlie the aquifer. To assess the water quality conditions beneath one septic system, Wenck Associates (Wenck) installed a vadose zone monitoring network to monitor septic leach field denitrification over Casper Formation outcrop.

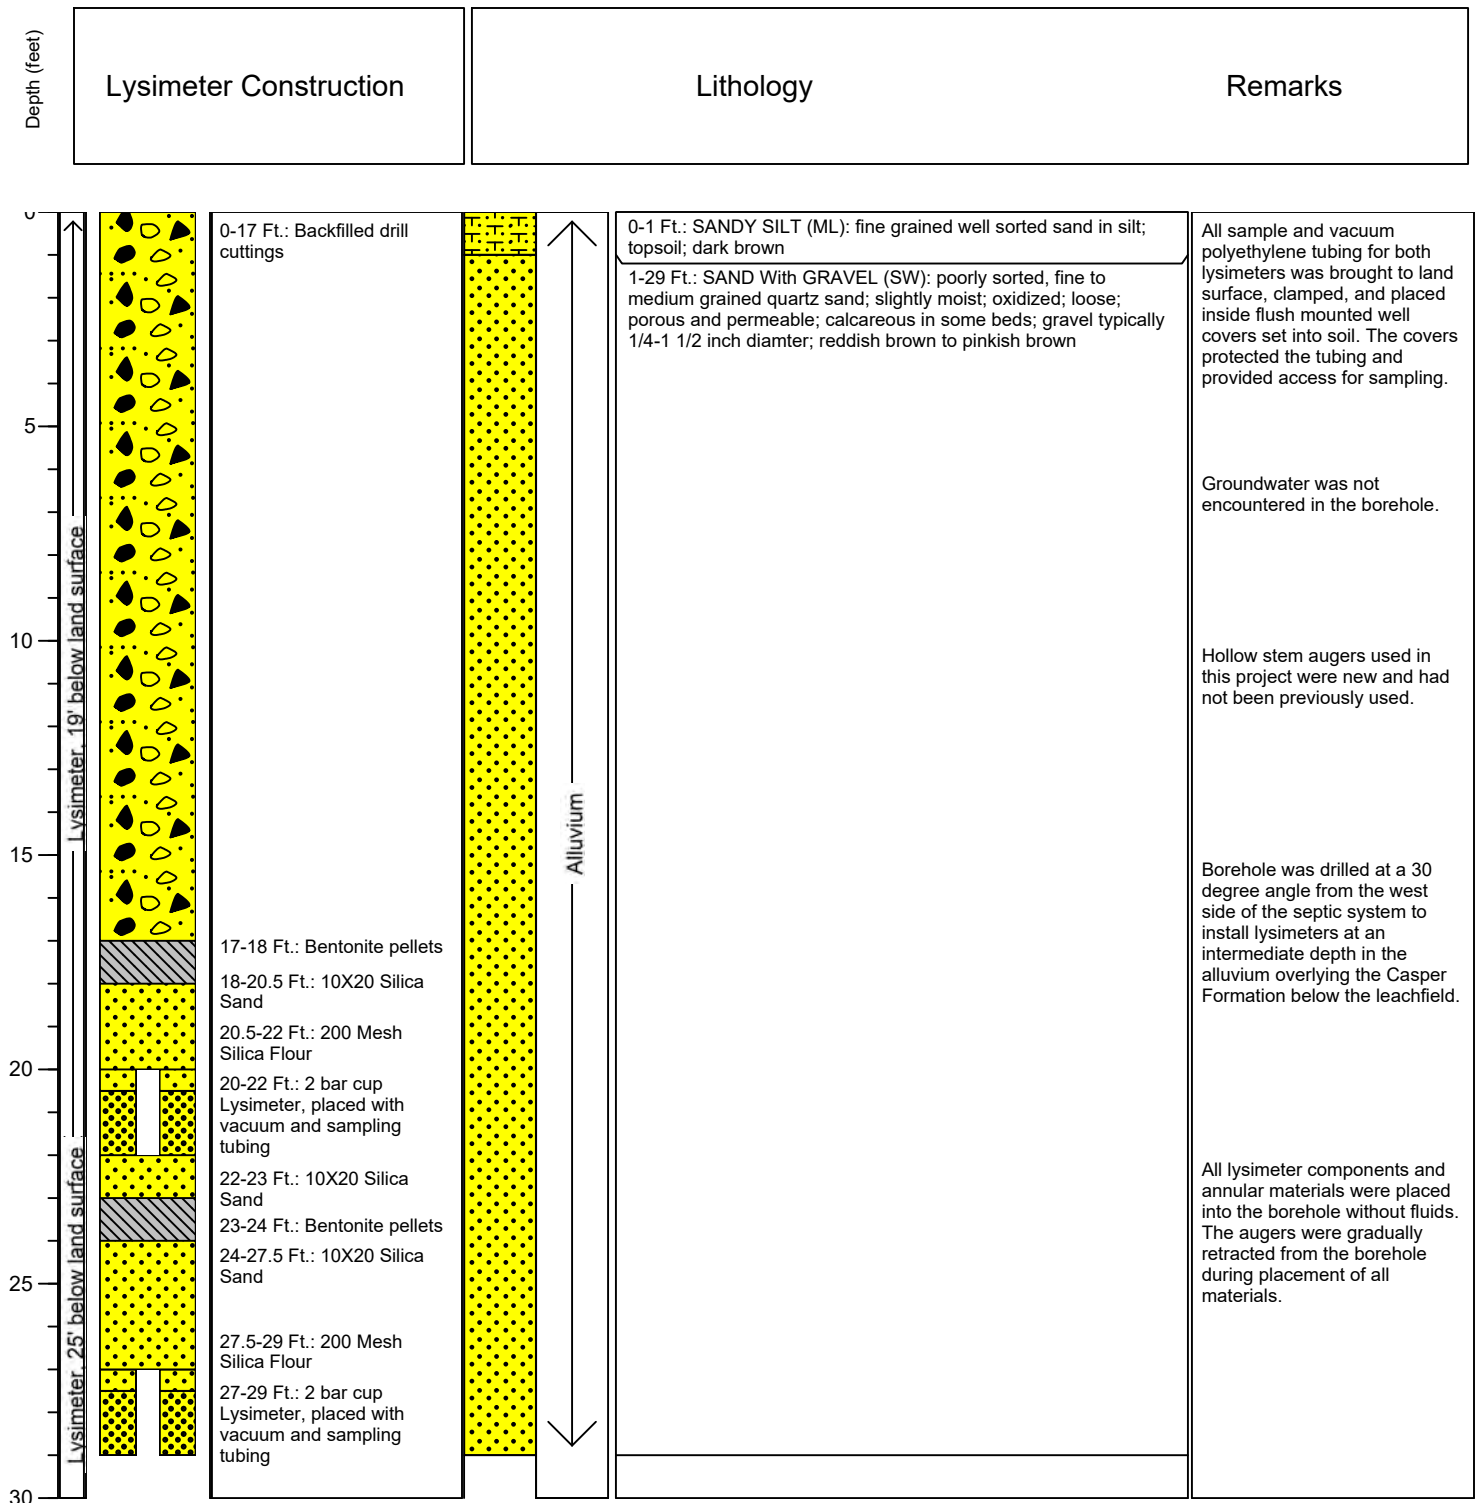
Well Name: L-2  
 Drilling Method: Hollow Stem Auger  
 Logged by: M. Stacy  
 Total depth: 29 Ft.  
 Elevation: 7,457 Ft.

Notes: This figure presents the as-built details for the L-2 lysimeter completed west of the septic system at 2225 Range View Lane in Laramie, Wyoming. This borehole was drilled at a 30 degree angle from vertical to install two, two foot long lysimeters in this one borehole at two different depths below the septic system.

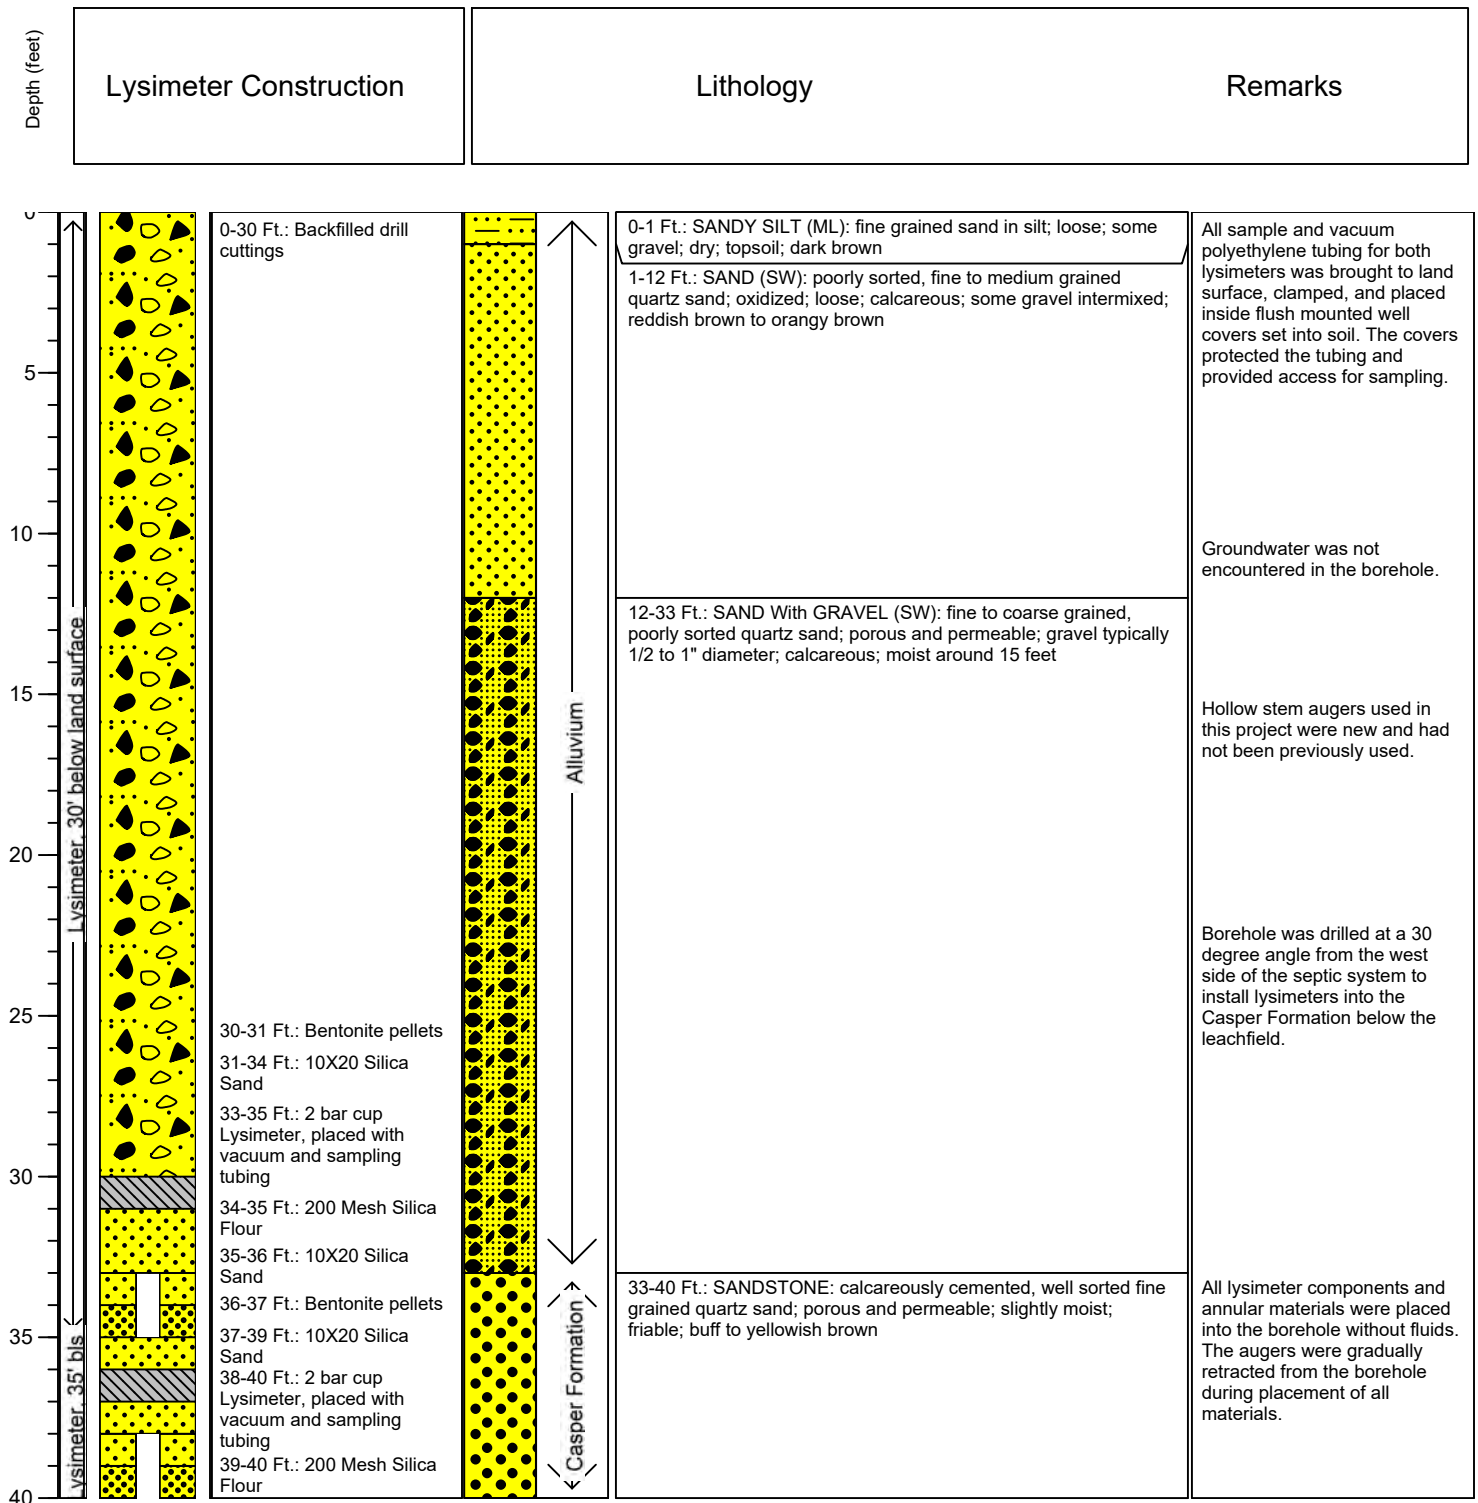
Well Name: L-3  
 Drilling Method: Hollow Stem Auger  
 Logged by: M. Stacy  
 Total depth: 40 Ft.  
 Elevation: 7,457 Ft.

Notes: This figure presents the as-built details for the L-3 lysimeter completed west of the septic system at 2225 Range View Lane in Laramie, Wyoming. This borehole was drilled at a 30 degree angle from vertical to install two, two foot long lysimeters in this one borehole at two different depths below the septic system.

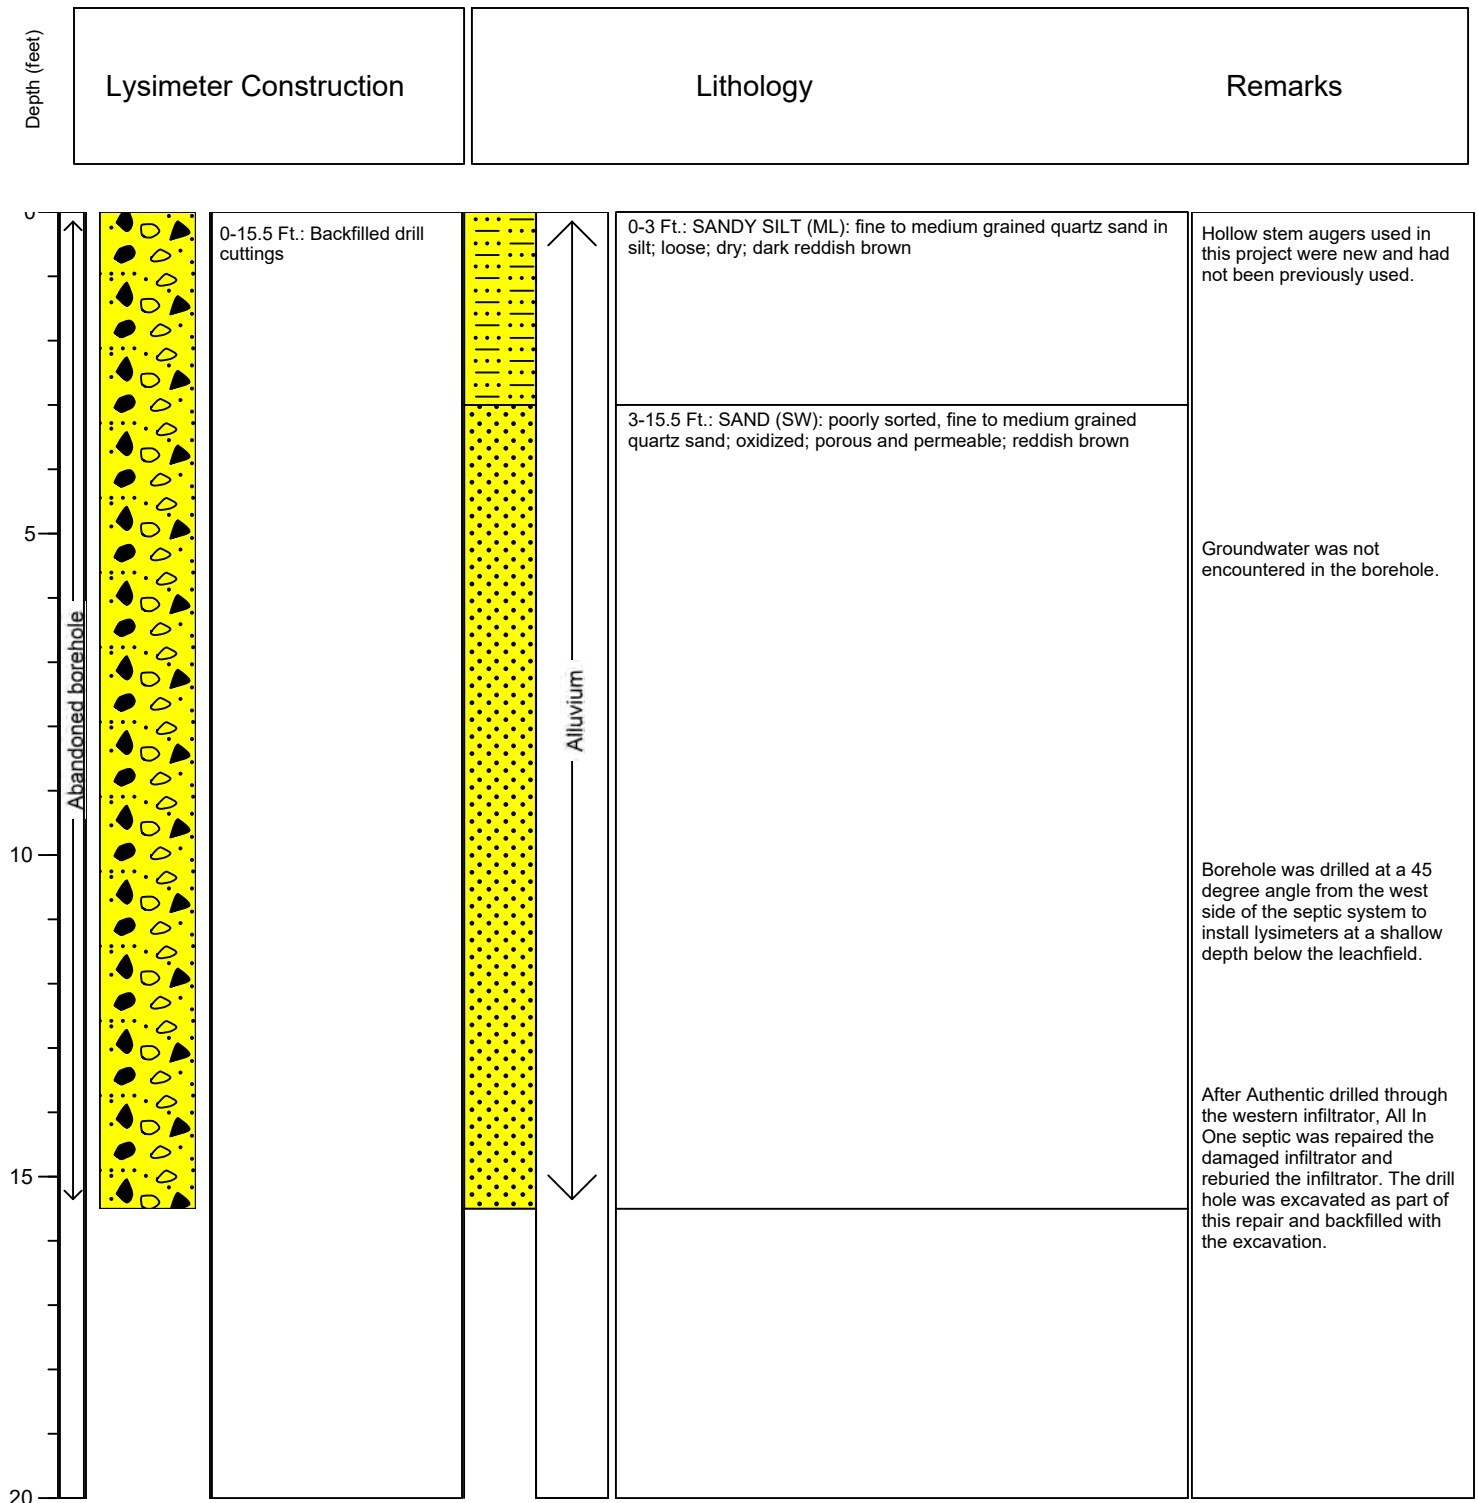
Well Name: L-4  
 Drilling Method: Hollow Stem Auger  
 Logged by: M. Stacy  
 Total depth: 15.5 Ft.  
 Elevation: 7,457 Ft.

Notes: This figure presents the as-built details for the L-4 lysimeter hole that was drilled north of the L-1 through L-3 lysimeters and west of the septic system at 2225 Range View Lane in Laramie, Wyoming. This hole was drilled before L-1 through L-3. This borehole was drilled at a 45 degree angle from vertical to install two, two foot long lysimeters in this one borehole. However, no lysimeters were installed in this hole after the western infiltrator was drilled through from the west side. All In One was called to the site, excavated down to and around the infiltrator, and repaired and reburied the damaged infiltrator.

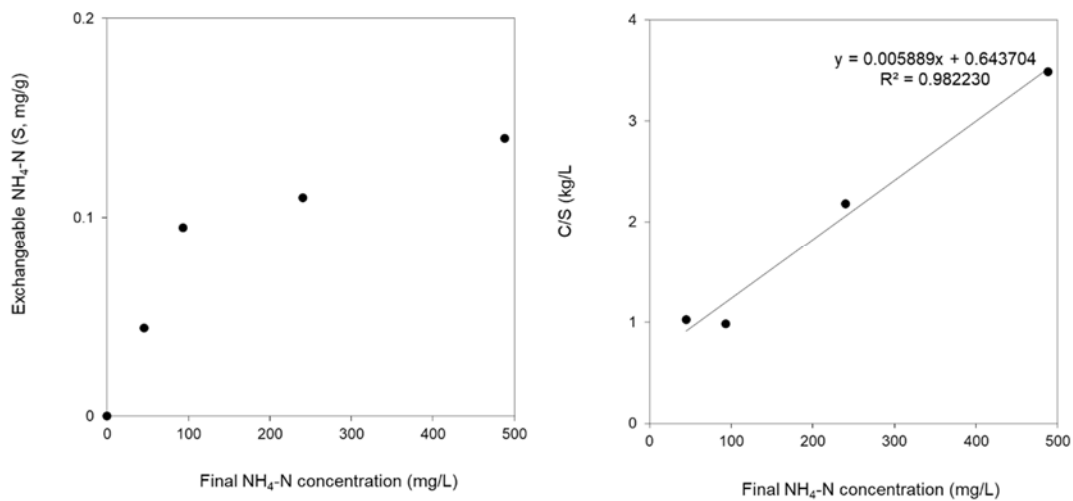
An example Langmuir isotherm is shown in Figure 1 for ammonium-N adsorption onto L2 subsoil. In this

Figure 1. Changes in adsorbed ammonium-N (i.e., exchangeable  $\text{NH}_4\text{-N}$ , left panel) and C/S versus final equilibrium  $\text{NH}_4\text{-N}$  concentration (right panel). The inverse of the C/S:S slope approximates  $S_{max}$  ( $1/0.005889 = \sim 170 \text{ mg/kg}$ ).

example, ammonium-N adsorption reached an asymptote at an equilibrium concentration of  $\sim 500 \text{ mg/L}$  and the sorption capacity was  $\sim 170 \text{ mg/kg}$  (i.e.,  $S_{max}$ ).

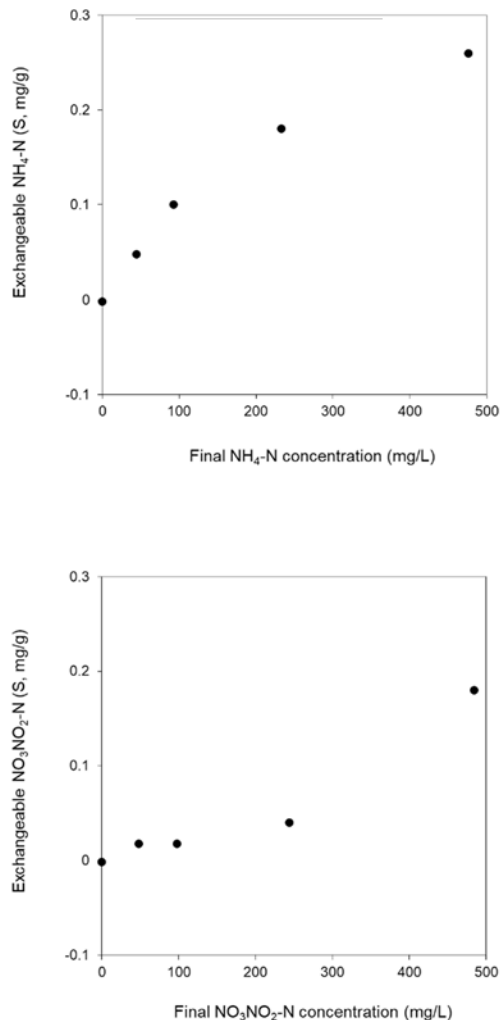
*Figure 2. An example of changes in adsorbed ammonium-N (i.e., exchangeable  $\text{NH}_4\text{-N}$ , upper panel) and adsorbed nitrate-nitrite N (i.e., exchangeable  $\text{NO}_3\text{NO}_2\text{-N}$ ) for B2-2 subsoil.*
