ALBANY COUNTY, WYOMING
I-80 TELEPHONE CANYON
CASPER AQUIFER PROTECTION STUDY

April 20, 2011

Project #: 161-002-001

SUBMITTED BY: Trihydro Corporation

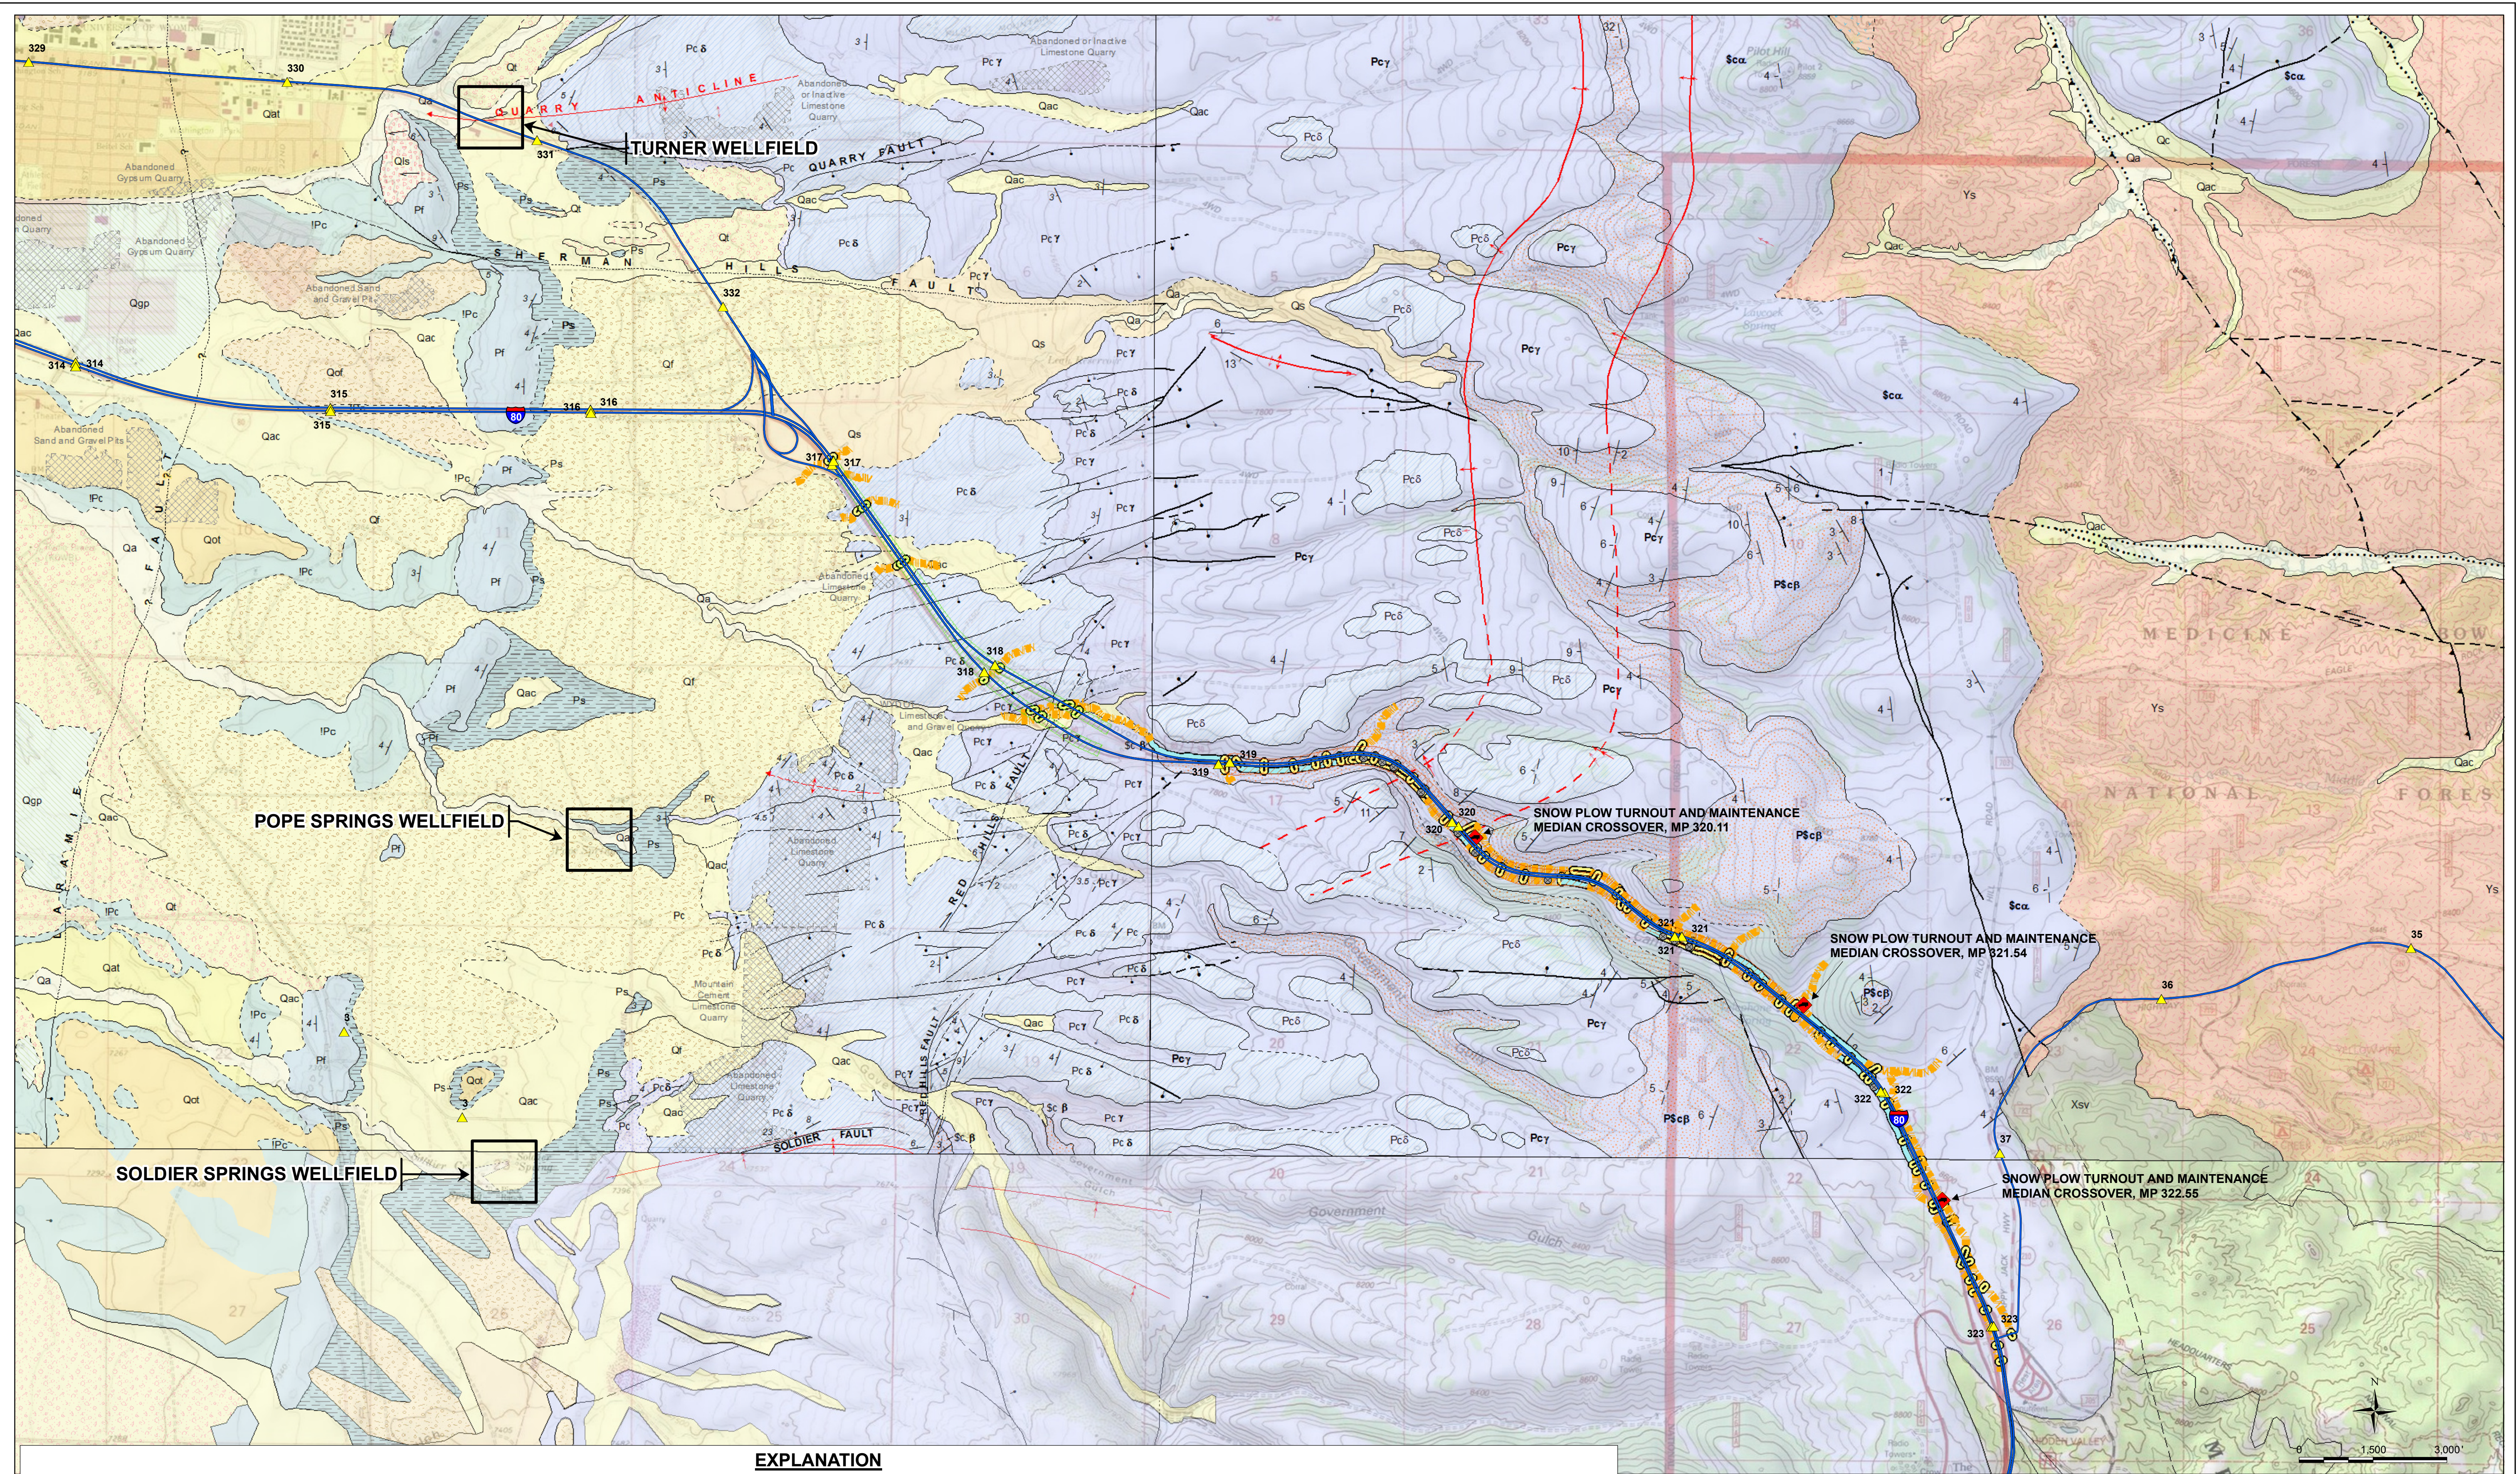
FIGURE 1
STUDY AREA
MP 317 TO MP 323
I-80 TELEPHONE CANYON
CASPER AQUIFER PROTECTION STUDY
LARAMIE, WYOMING

southwest of I-80 to the Pope Springs and Soldier Springs well fields, collectively known as the “City Wells” (Figure 1). This report is not intended to duplicate efforts from existing city or county documents about the Casper Aquifer. The purpose of this report is to conduct an independent study to evaluate possible hazardous material spill response and mitigation measures in the study area using the existing CAPP documents as reference materials for this study. Specifically, this report will:

Several geologic formations, or distinctive rock units, are present in the Laramie area. Formations and units pertinent to the delineation of the CAPA include the sequence from the Sherman Granite upwards to the Satanka Shale (Figure 1). Following is a summary of these units.

The Precambrian Sherman Granite is an igneous rock that is exposed east of the crest of the Laramie Range (Figure 1). The Sherman Granite was formed by the slow cooling of magma (liquid rock) and is a large mass of interlocking minerals. The igneous Sherman Granite is distinctly different than the overlying formations which are layered sedimentary rocks.

The Pennsylvanian-Permian Casper Formation overlies the Fountain Formation, where the Fountain is present, or the Precambrian rocks where the Fountain is absent. The Casper Formation is approximately 700 feet thick and is composed of sandstones interbedded with limestone and minor amounts of shale. The Casper Formation is approximately 85% sandstone with limestone comprising the remainder of the formation. The Casper Formation is informally subdivided, from bottom to the top, into five members designated alpha, beta, gamma, delta, and epsilon. Each of these layers consists of sandstone and is bounded at the top by a layer of limestone (Lundy, 1978). The Casper Formation surfaces on the west flank of the Laramie Range, east of the City of Laramie (Figure 1).

The study area, for purposes of this report, encompasses a portion of the Casper Aquifer. The study is confined to the right-of-way of I-80 between milepost 316.7 and 323.05. Figure 1 shows the study area in relation to Pope Springs and Soldier Springs wells, located south of I-80 and southeast of the City of Laramie, as well as the Turner Wells, located northwest of I-80.

A vulnerability ranking of 1-3 was assigned to each one mile section of highway in the study area based on the number of mapped faults and folds (Figure 1) to assess the geologic vulnerability of the I-80 corridor to the west of and through Telephone Canyon. A ranking of 1 indicates little to no faulting in the formation and a 3 indicates the formation is highly faulted. Faults and folds that did not intersect the roadway were not considered in the evaluation.

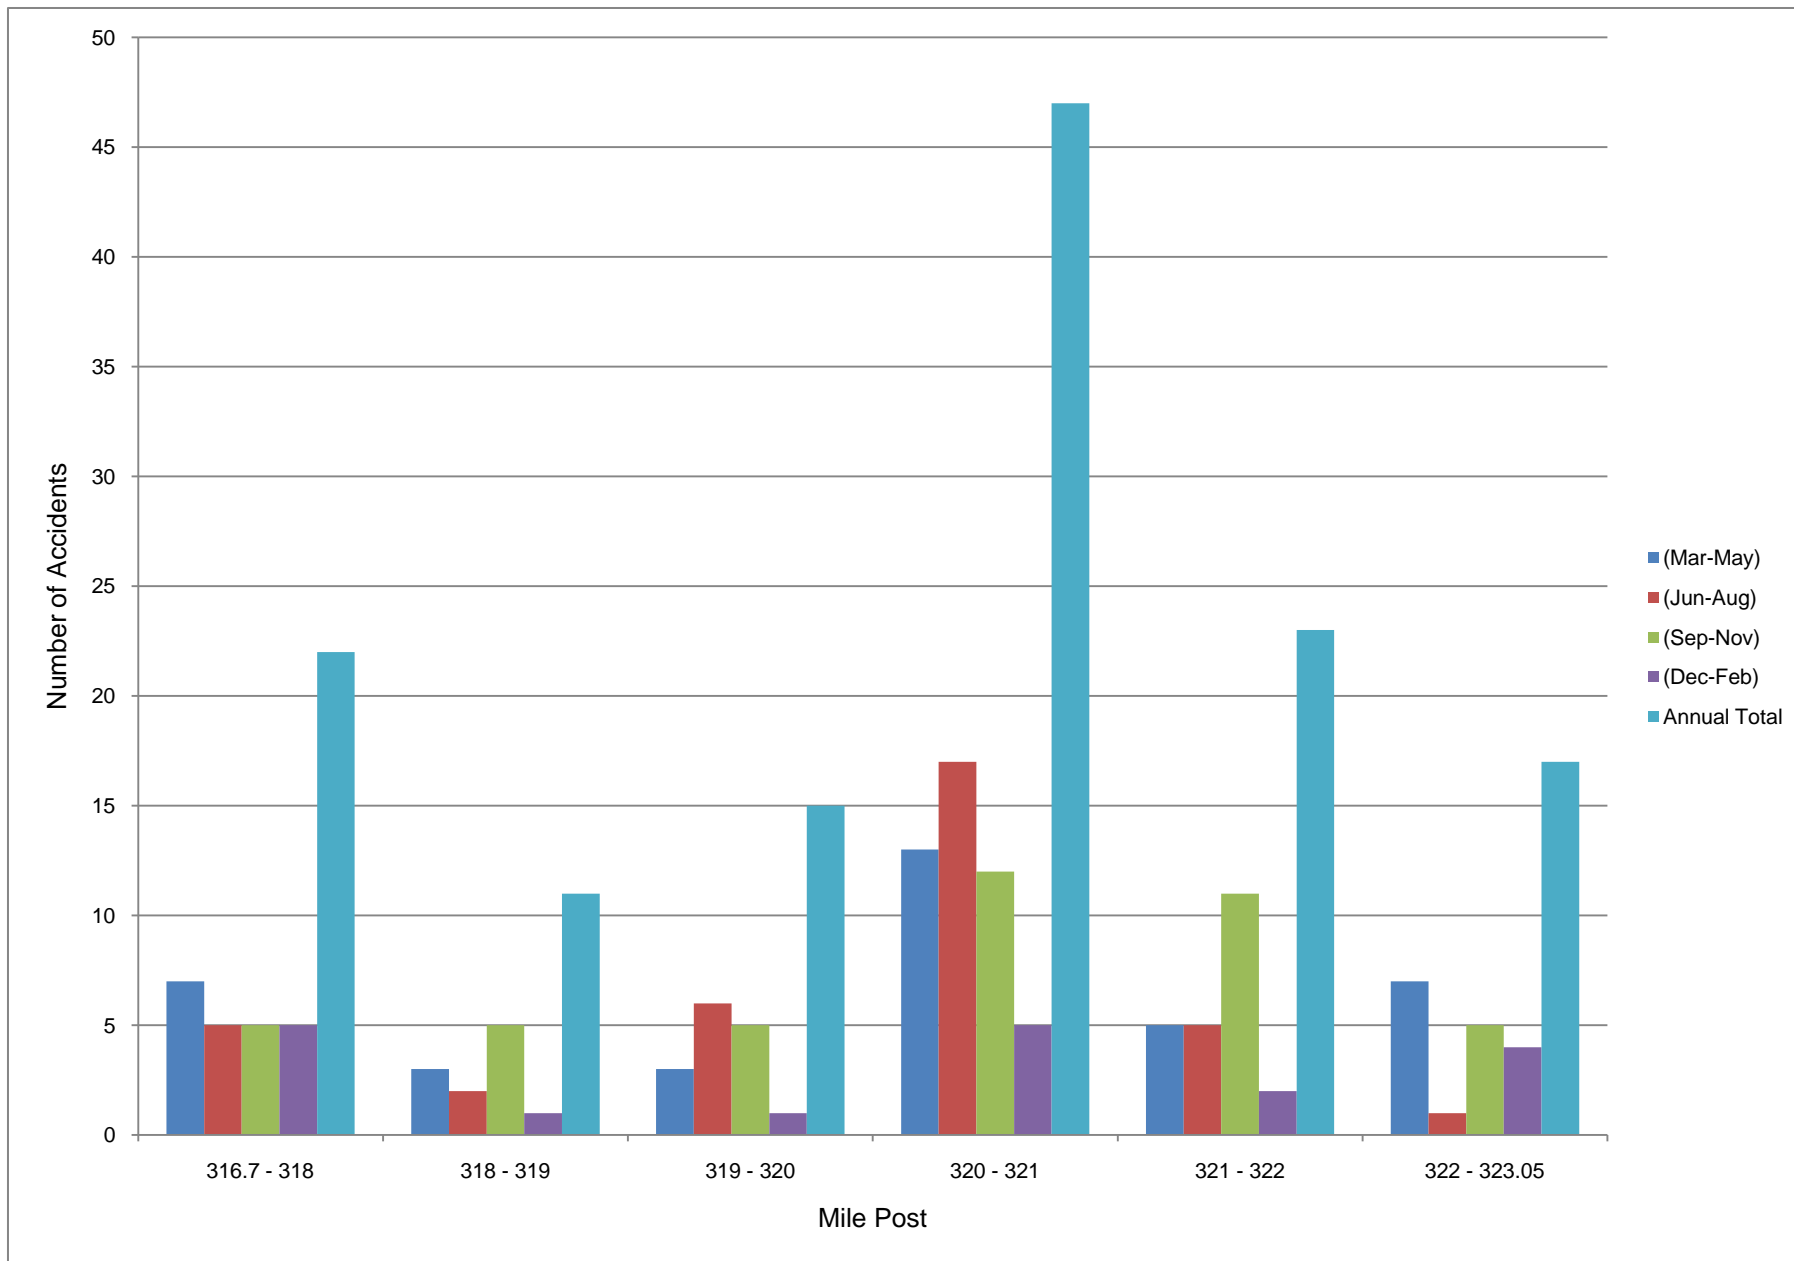
FIGURE 2. TRUCK ACCIDENTS BY SEASON
CASPER AQUIFER PROTECTION STUDY, I-80 TELEPHONE CANYON, ALBANY COUNTY, WYOMING

The data were also evaluated based on the seasonal variation of accidents in the study area. Of the total semi-truck accidents, the highest number occurred in the fall (September to November) and spring (March to May), when weather conditions tend to change most frequently and rapidly. Interestingly, the number of accidents decreased in the winter months (18 truck accidents), and it is assumed that this may be a result of drivers being more careful and possibly reducing speeds when conditions are known to be hazardous (Figure 2).

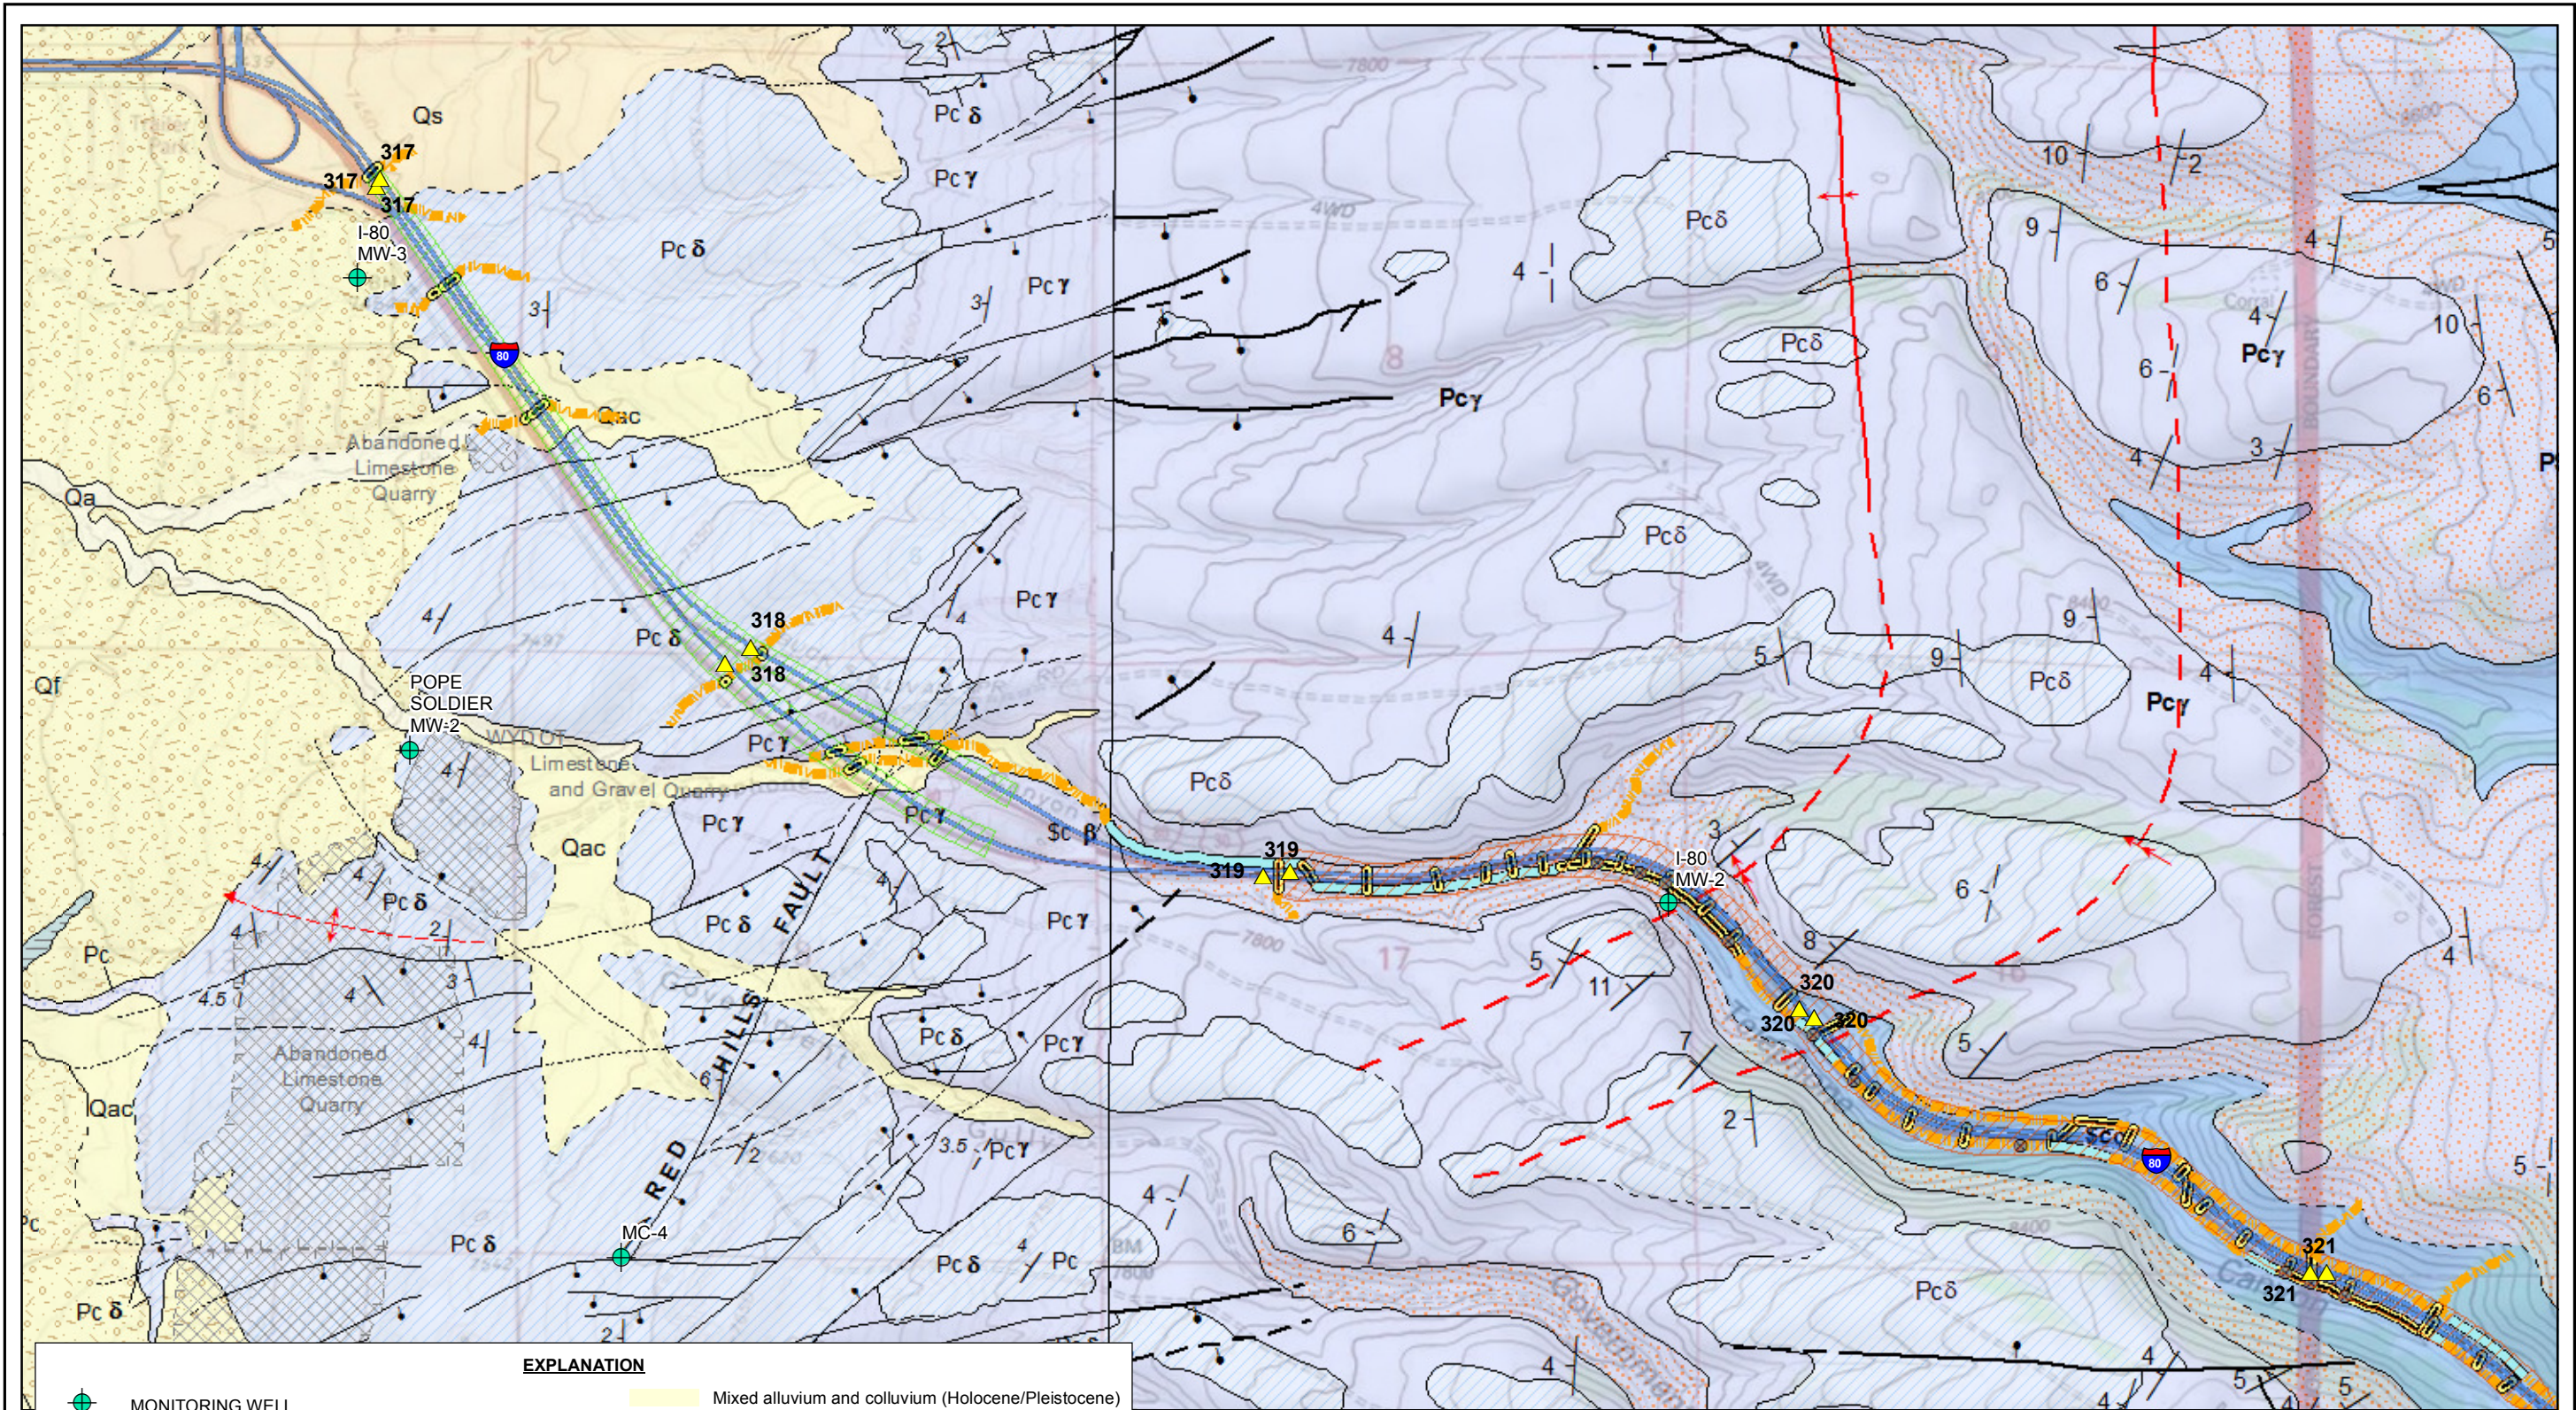
FIGURE 4
PROPOSED MONITORING WELL LOCATIONS
I-80 TELEPHONE CANYON
CASPER AQUIFER PROTECTION STUDY
LARAMIE, WYOMING

Figure 4 shows locations to consider for monitoring well locations. Table 4 shows the estimated cost for four monitoring wells, access easements, and purchase of property surrounding each well. Assumptions are listed at the top of the table. The estimated cost for this option is \$470,000.

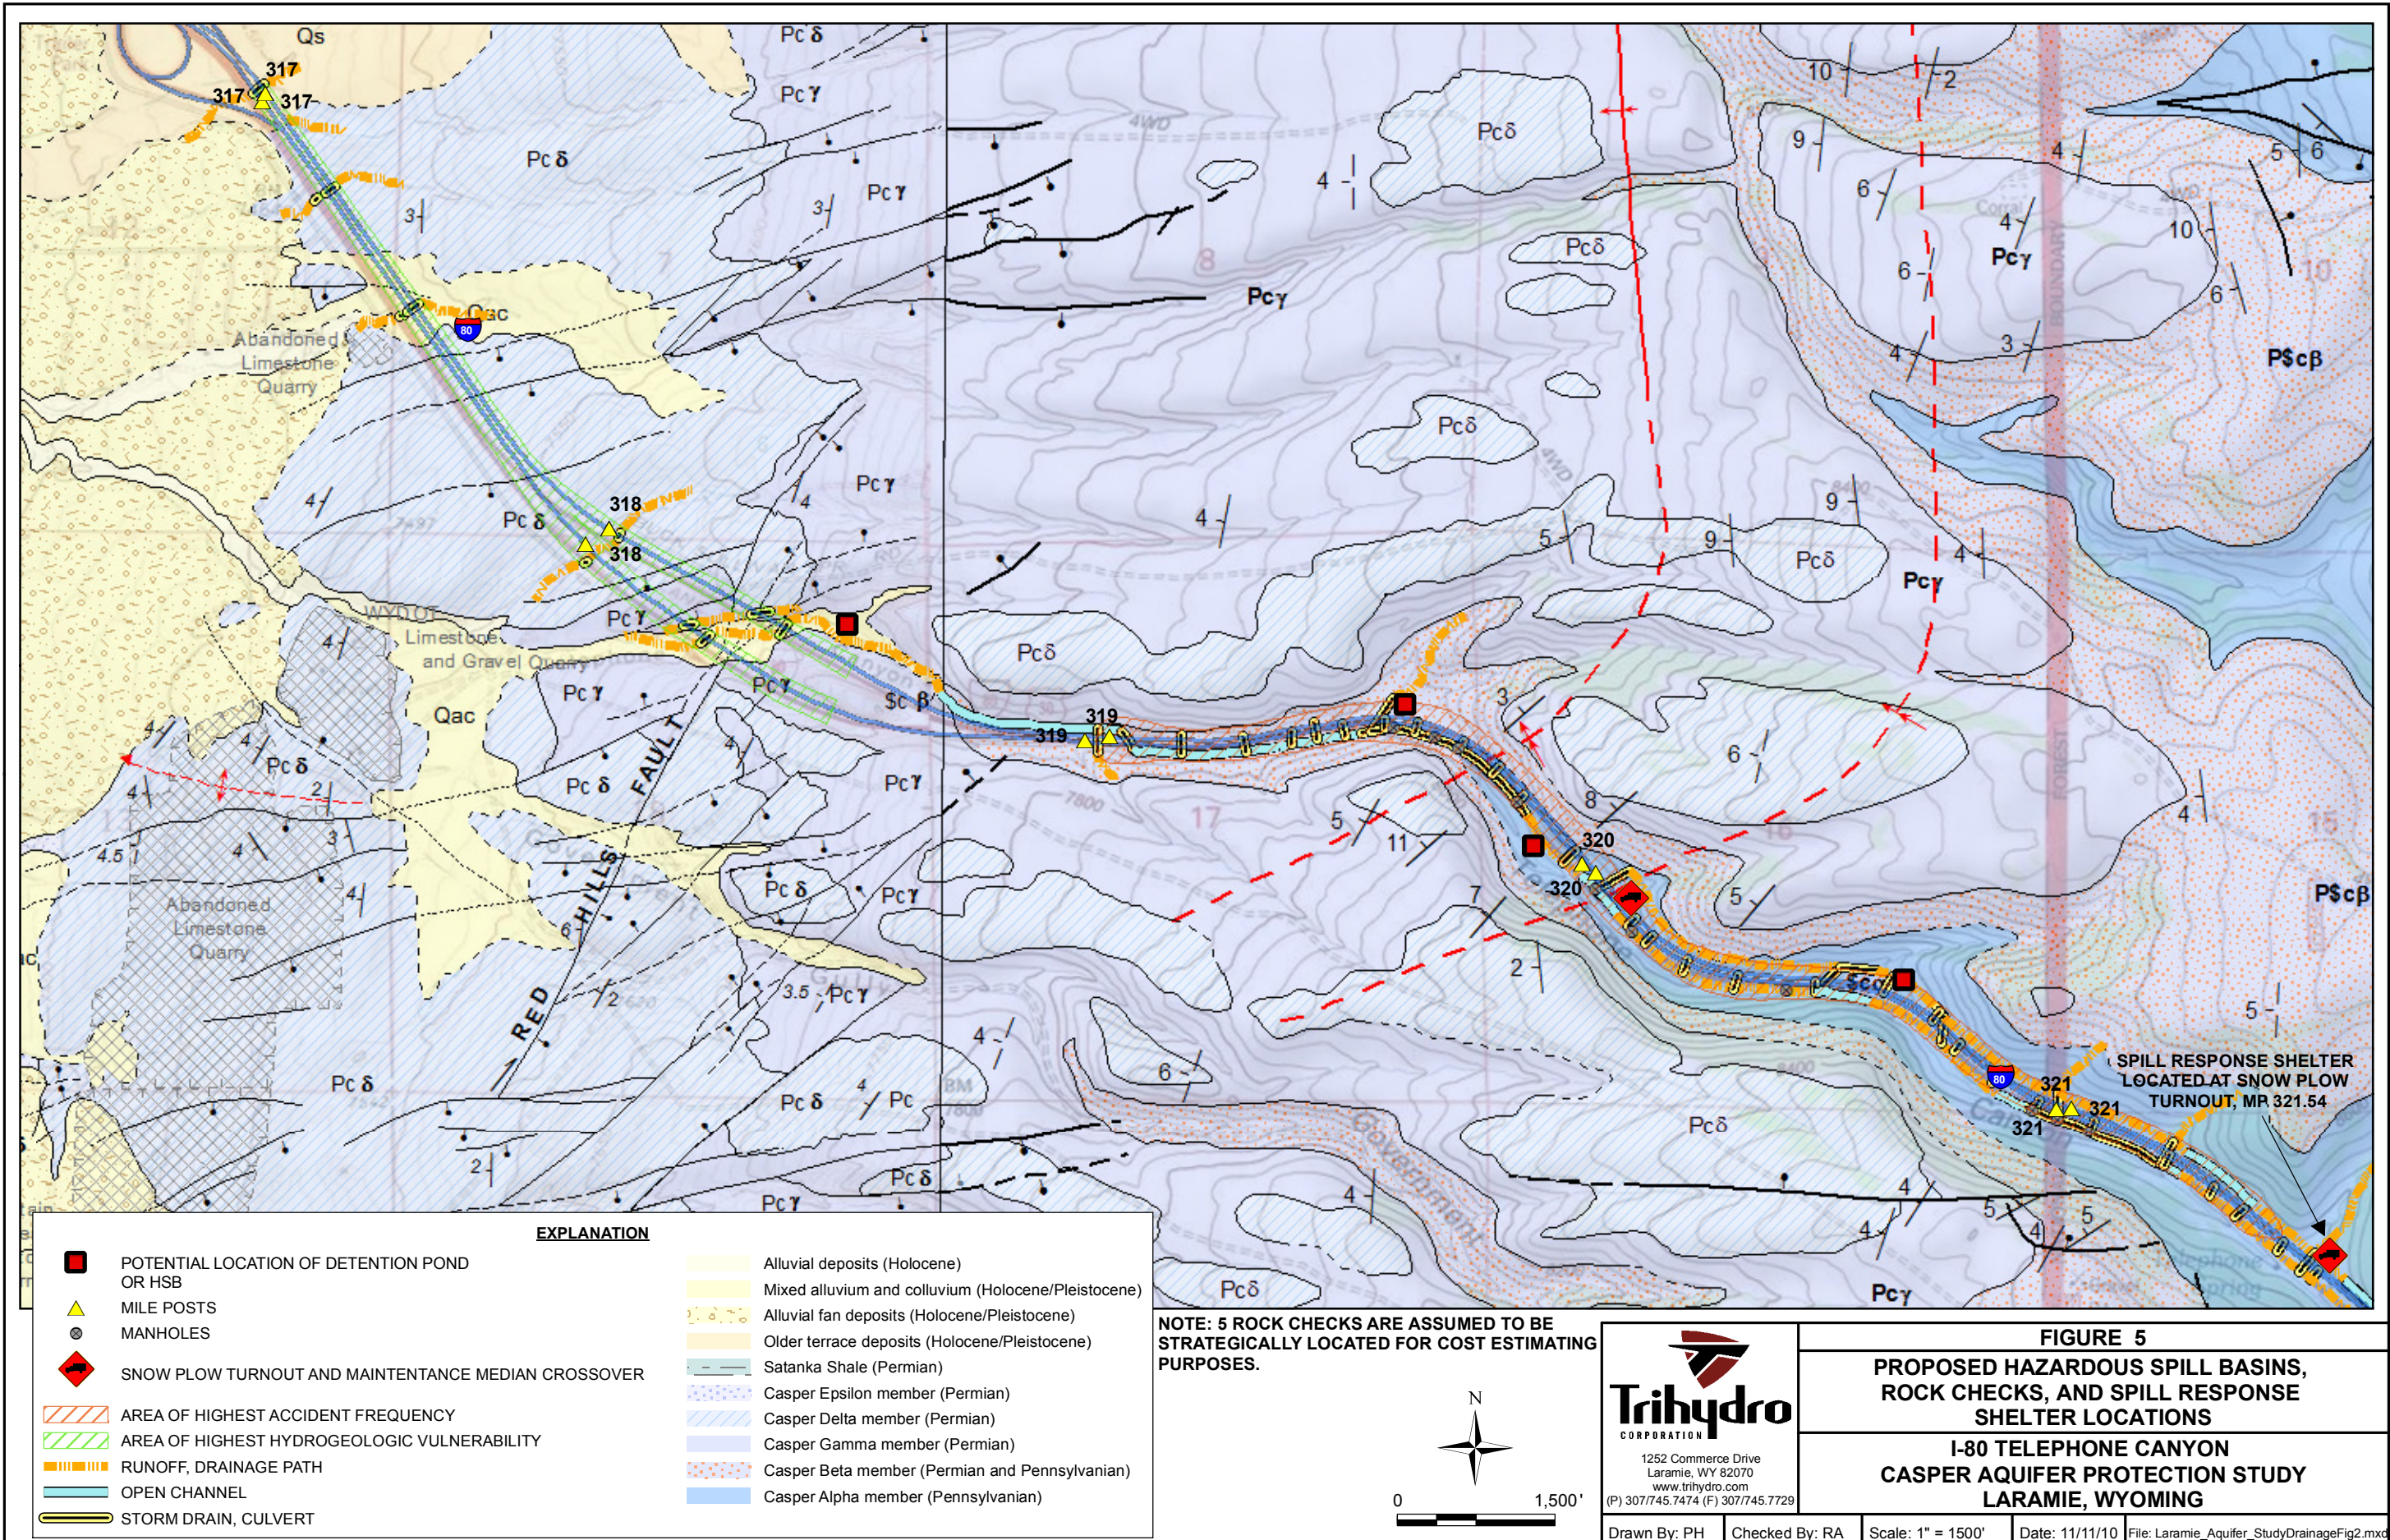
FIGURE 5
PROPOSED HAZARDOUS SPILL BASINS, ROCK CHECKS, AND SPILL RESPONSE SHELTER LOCATIONS
I-80 TELEPHONE CANYON
CASPER AQUIFER PROTECTION STUDY
LARAMIE, WYOMING

Figure 5 shows possible locations for HSBs and rock checks with a supply shelter location included for emergency response supplies. The supply shelter is shown at a snowplow turnout located at milepost 321.54, which is in close proximity to the segment of roadway that experiences the highest frequency of truck accidents. The location of this supply shelter should be evaluated to optimize the availability of supplies to response teams in the event of a spill. It may be beneficial to have multiple supply shelters at the top and bottom of the canyon in the event that access is limited due to an accident blocking traffic. Table 5 presents a conceptual construction cost estimate based on the assumptions at the top of the table. Further study and site investigations are recommended to locate and size the HSBs and rock checks within the canyon. The estimated cost to implement this option is \$230,000.

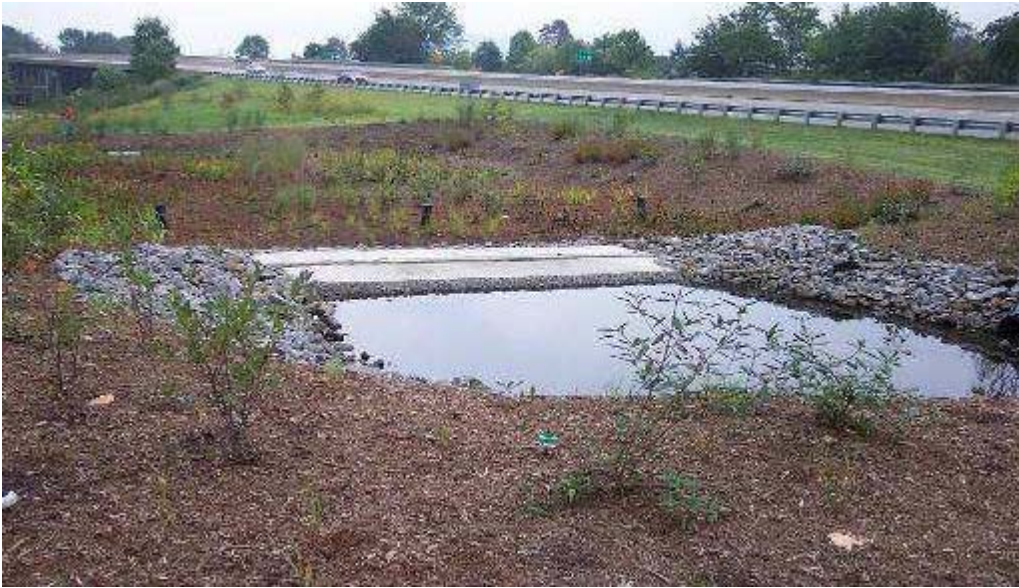
Detention pond (background) with forebay (foreground)

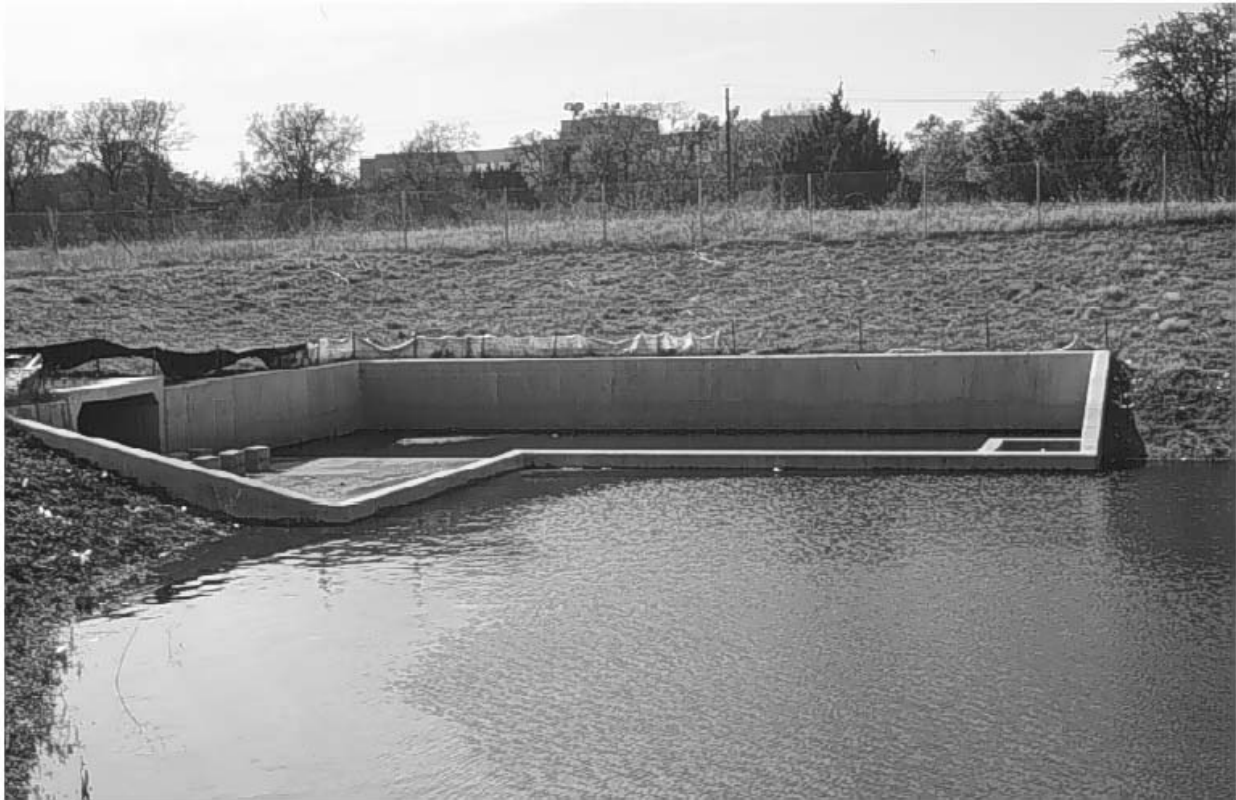
Concrete lined detention pond in Austin, TX

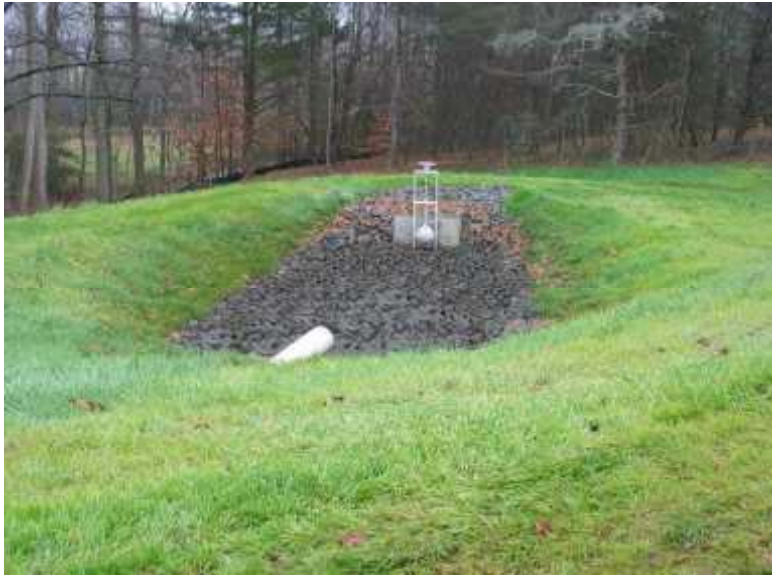
Hazardous Spill Basin

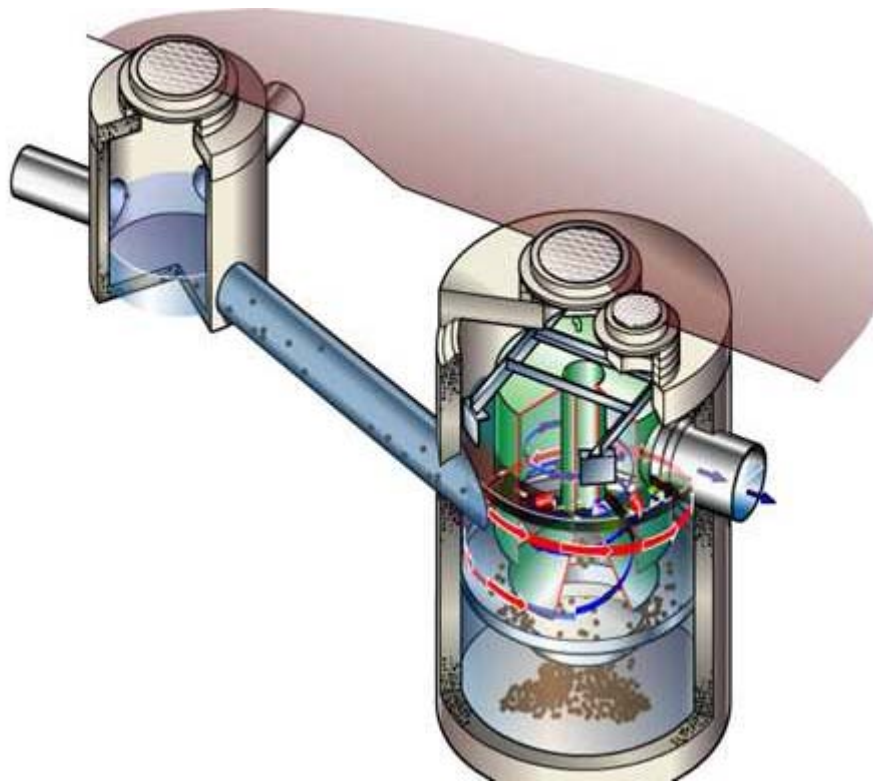
Swirl Concentrator

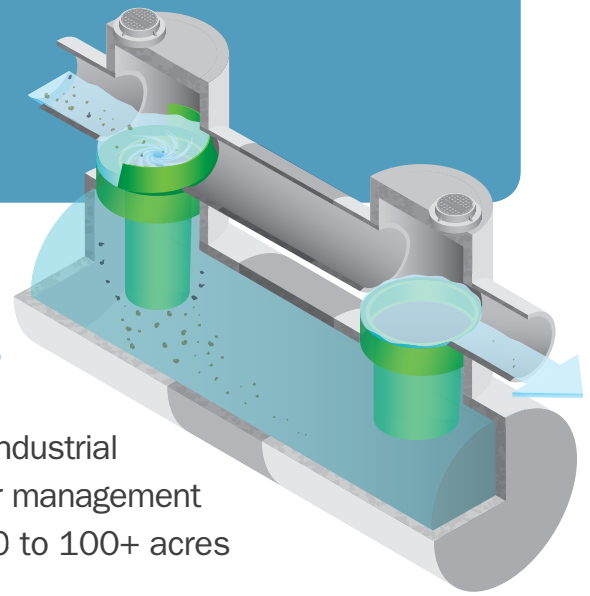
One system for your large stormwater capacity needs

The StormceptorMAX responds to the needs of large-scale industrial and residential areas which may require a single stormwater management device. It provides stormwater quality treatment for areas 20 to 100+ acres and industrial spill volume capture of 15,000+ gallons.
