Re: Site Specific Investigation  
Upland Heights B4  
Technical Review

This letter serves to present the findings of our technical review of the site specific investigation prepared by WWC Engineering (WWC) and presented to City of Laramie for the future development of the Upland Heights B4 Lot located within the Casper Aquifer Protection Area. Our review comments will be presented to address the adequacy of this site specific investigation in fulfilling the requirements of the City of Laramie's Unified Development Code, subsection 15.08.040.A.8.

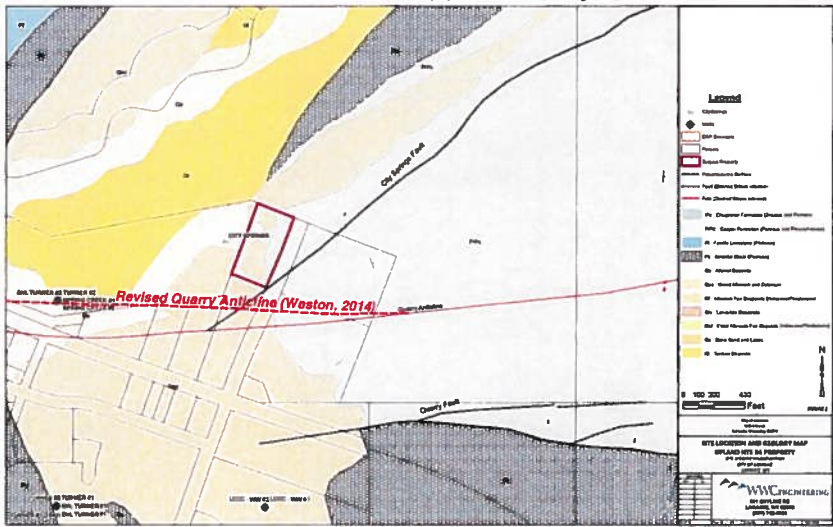
WWC identified three structural features near Upland Heights B4 Lot – two faults (City Springs and Quarry Faults) and a structural fold (Quarry Anticline). The Quarry Fault is well outside of the required vulnerable feature setback distance of 100 feet (City of Laramie Unified Development Code, subsection 15.08.040.A.7(b)). WWC has indicated that the City Springs fault is approximately 10 feet southeast of the property boundary. The third feature – the hinge axis of the Quarry Anticline is shown by WWC to be approximately 250 south of Lot B4. However, based on field work performed by Weston Engineering (Weston), Weston proposed that the fold axis of the Quarry Anticline may actually be located further to the north than that mapped by Ver Ploeg (2009) as shown in the adjacent figure. However, this fold axis would still be beyond the 100 foot setback distance.

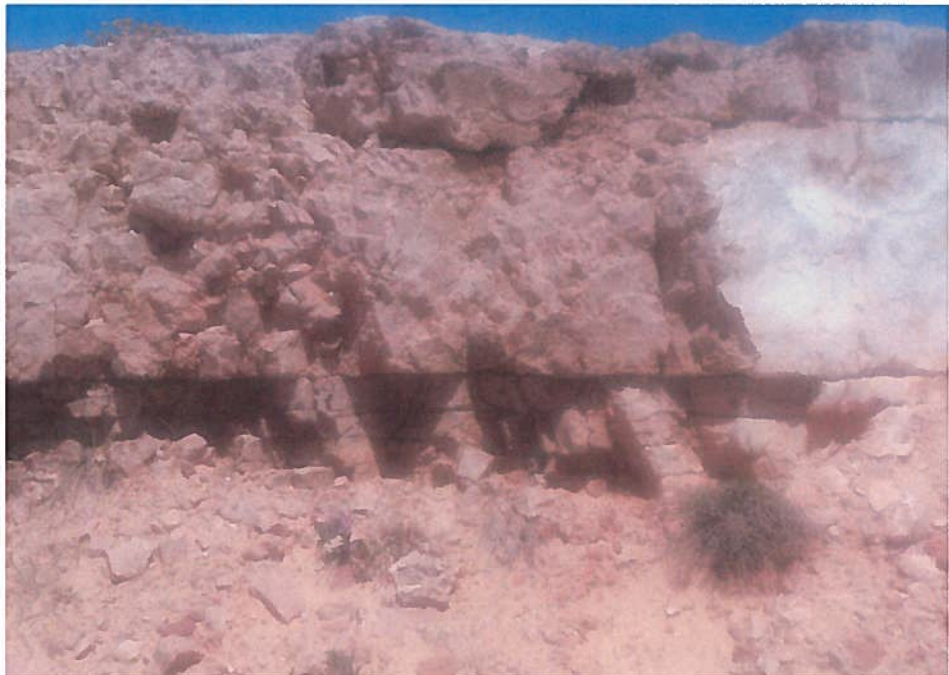
As discussed under the 15.08.040.A.8(d)(i) section, there are several vulnerable features located in Lot B4 or within the setback distance. WWC conducted a site investigation of this area on August 17, 2017 to verify the existing mapping of the vulnerable features and to document any additional features. WWC's narrative describes three of these vulnerable features – the City Springs Fault, City Springs and its associated drainage and the Quarry Anticline. The SSI report mentions the potential existence of fractures in the rock units as a result of the folding associated with the Quarry Anticline, however, it did not mention that the City Springs Fault may also cause significant fracturing to occur. It should also be pointed out that downhole video logging of Casper Formation wells in the Laramie area shows that horizontal or bedding plane fractures or solution caverns are prominent in many of these wells. The picture below was taken along the cut face of the outcropping Casper Formation in the Upland Heights Lot B5 area and shows the voids in the formation associated with the bedding planes and some horizontal fracturing.

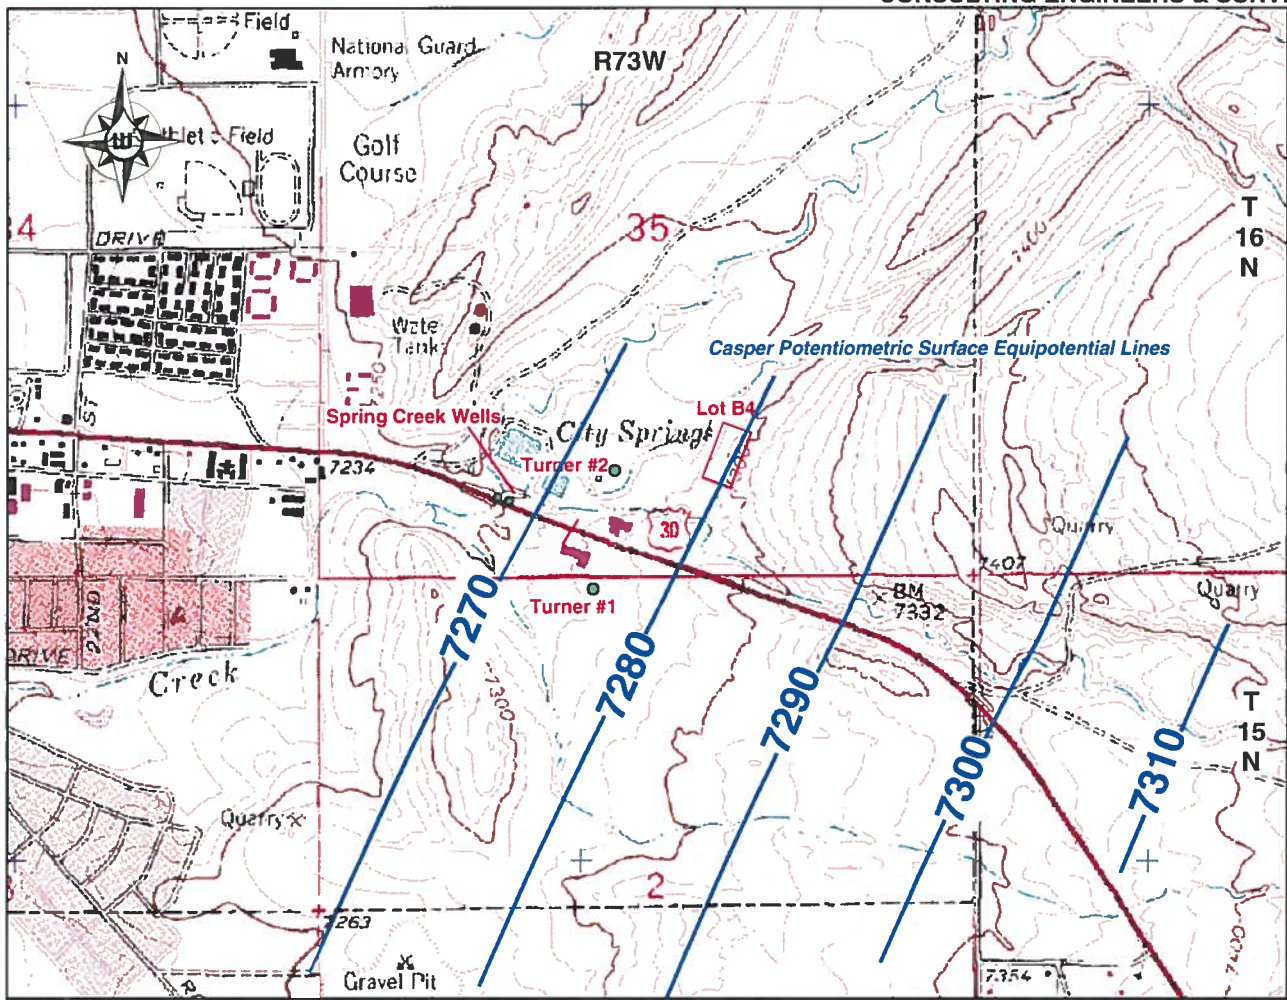
WWC performed a very thorough review of the potential surface water flows in the subject area. Figure 3 would have been a little easier to read if the elevation contours would have been labeled. It is difficult to perform a risk assessment and provide a mitigation plan without a site plan for the lot. Without the site plan information, Engineering Associates feels that the information provided by WWC (i.e. the 100 year storm event runoff) is the extent of information that can be provided for this section of the SSI.
